Brushy Creek Municipal Utility District

Water & Wastewater Master Plan

Water and Wastewater Master Plan

Garver Project No. 2301754

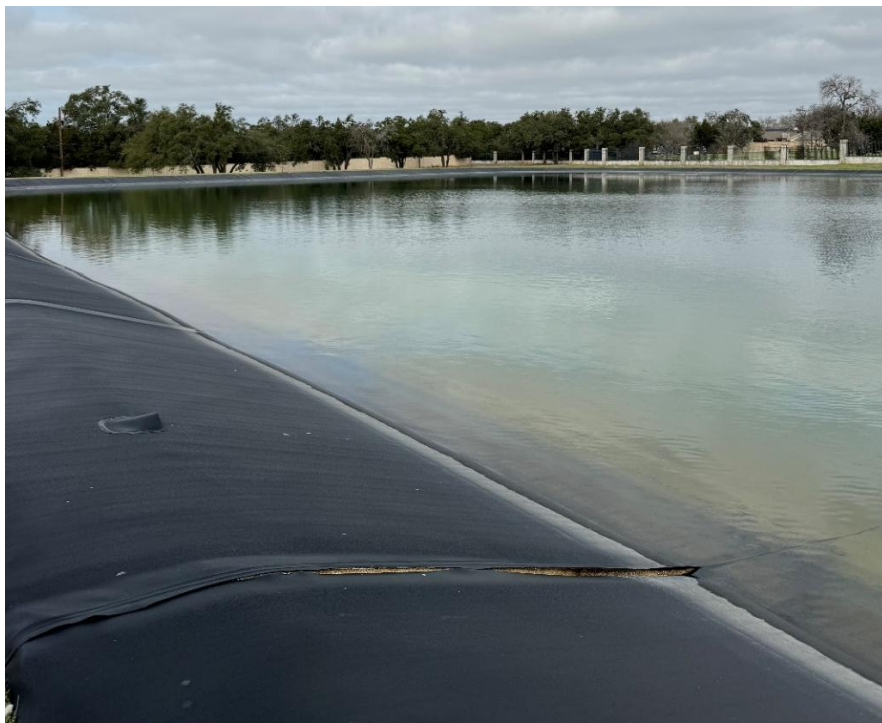
Figure 3-6: Raw Water Storage Pond

caused the HDPE geomembrane to crack and tear in multiple locations. Specifically, the areas exposed to the UV sunlight have suffered the most distress. An example of a split in the geomembrane liner is shown in Figure 3-6 below, though this tear has since been repaired.

While the liner was being repaired, Titan Environmental USA conducted an integrity test of the liner in 2024. This included a break elongation test and a stress crack resistance test. Based on the results, presented in **Appendix C**, Titan Environmental USA recommended to replace the HDPE geomembrane of the raw water storage pond. Garver concurs with Titan Environmental USAs recommendation, and has developed a CIP to provide BCMUD with the means to execute the project as shown in Section 9.0, that is scheduled to be implemented within the zero-to-five-year planning horizon.

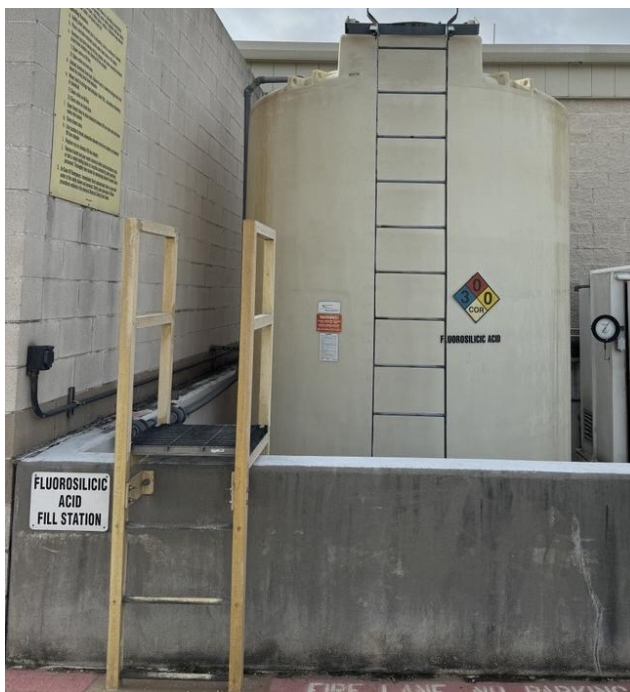
Figure 3-7: Fluorosilicic Acid Tank

Garver recommends demolishing the existing fluorosilicic acid storage tank, shown in Figure 3-7, because it has reached the end of its service life and poses potential risks due to structural degradation. BCMUD also ceased feeding fluorosilicic acid in April 2024. This project will involve safely removing the tank and disposing of any residual fluoride in accordance with environmental regulations.

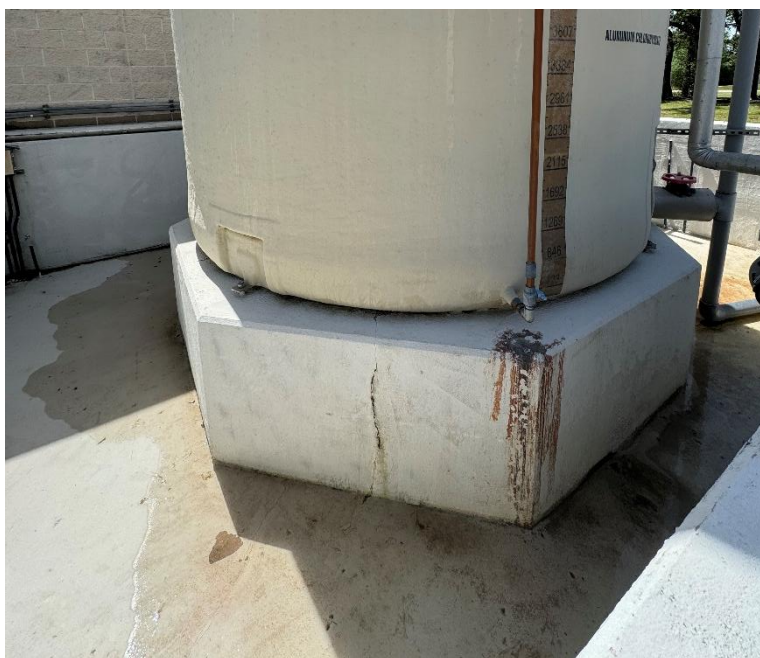
Figure 3-8: Standing Water in Outdoor Chemical Storage Area

The sump pumps in the LAS and ACH storage area are outdated and prone to frequent failures which allow standing water and chemicals as shown in Figure 3-8 to accumulate. It is recommended that BCMUD replaces these sump pumps with newer corrosion resistant models.

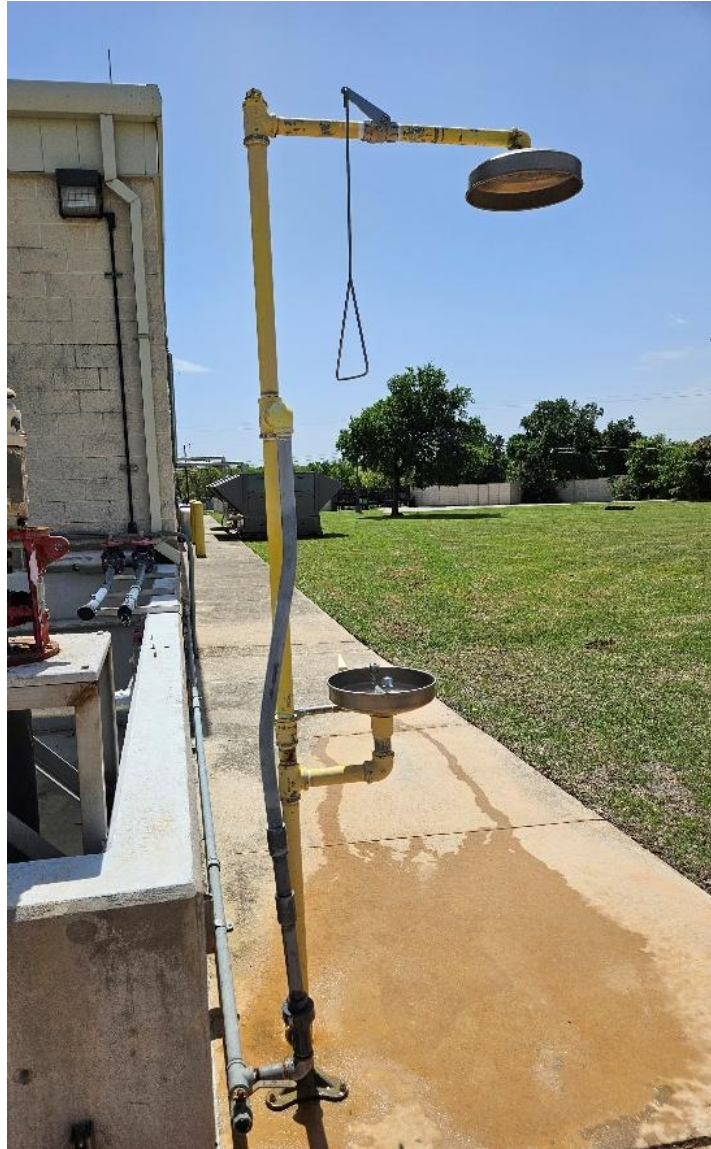
Figure 3-9: Emergency Eyewash Station

The emergency eyewash and shower station, shown in Figure 3-9, is critical for worker safety to rinse in the event of chemical exposure incident. To operate the emergency eyewash and shower station during cold weather events, it is recommended to replace it with a new station that contains insulation, and heat tracing in the unit. This will prevent freezing and allow the station to be ready for use in extreme weather events, thereby enhancing workers' safety. Additionally, when installing the new station, install in parallel a flow switch to improve the operational safety by alerting SCADA that the station has turned on, allowing operators to check the station and assist whoever may be present.

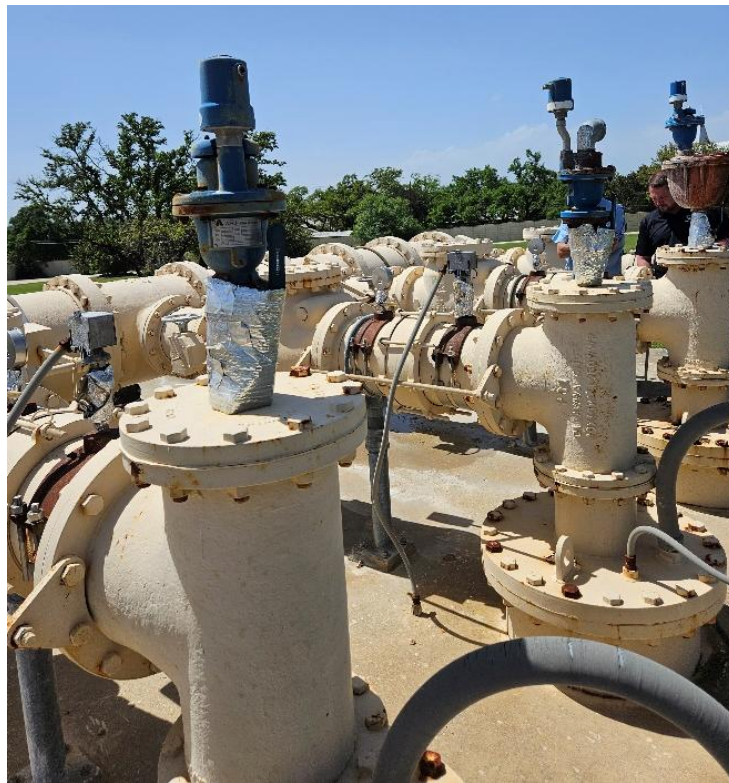
Figure 3-17: Membrane Feed Pumps

In the future, it is recommended to replace the three 2,000 gallon per minute (gpm) MF feed pumps and the one 1,300 gpm MF feed pump as they are reaching the end of their service life. These upgrades to the MF feed pumps, shown in Figure 3-17, will improve flow stability and system reliability, while reducing maintenance demands.

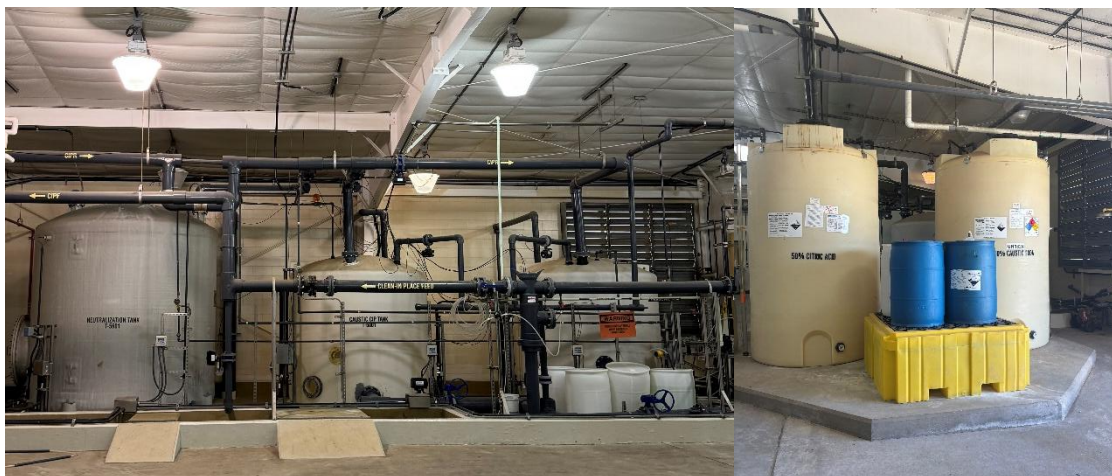
Figure 3-18: Clean-in-Place System

Several upgrades are proposed for the Clean-in-Place System, shown in Figure 3-18, due to age and degradation to enhance its performance and monitoring capabilities. These include replacing all flow meters to ensure accurate flow measurement. Additionally, due to their age and critical function in draining racks and transferring waste to the neutralization system, both the Clean-in-Place system feed pump and the filter drain pump should be replaced.

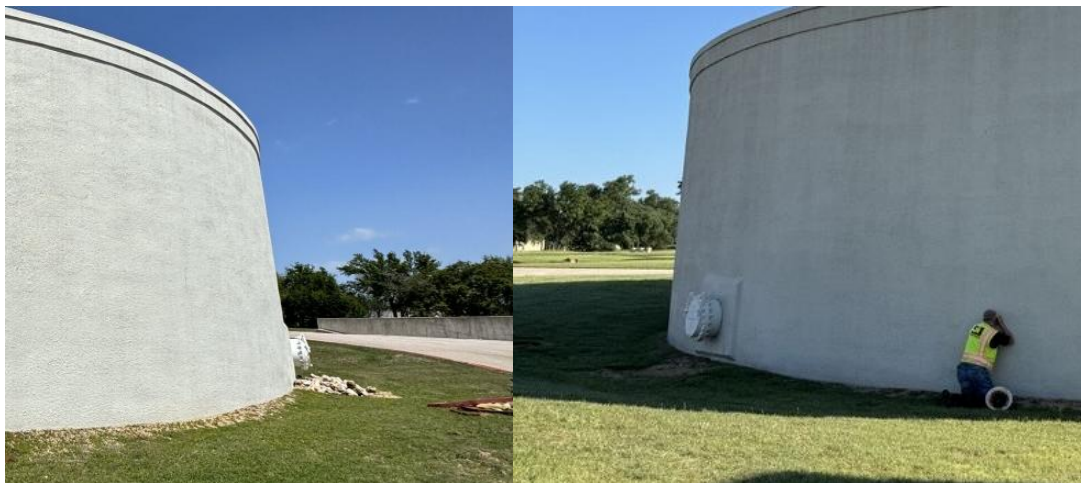
Figure 3-20: Clearwell Existing Drainage Infrastructure (Left: Clearwell #1, Right: Clearwell #2)

For Clearwell #1, it is recommended to add a continual gravel overflow to help manage overflow water effectively and direct the flow properly to the pavement. It is also recommended to install a drain for the clearwell to be emptied, as well as a tank mixer as specifically requested by BCMUD staff. For Clearwell #2, similar upgrades are proposed, including the addition of an overflow splash pad similar to the existing infrastructure at Clearwell #1, and to install a dedicated drainage system for the overflow to manage and mitigate the water and reroute it away from the recommended location of the emergency interconnect vaults. The existing drainage infrastructure is shown in Figure 3-20. Refurbishing the wire mesh at the overflow of both clearwells will restore effectiveness in screening debris and maintaining water quality.

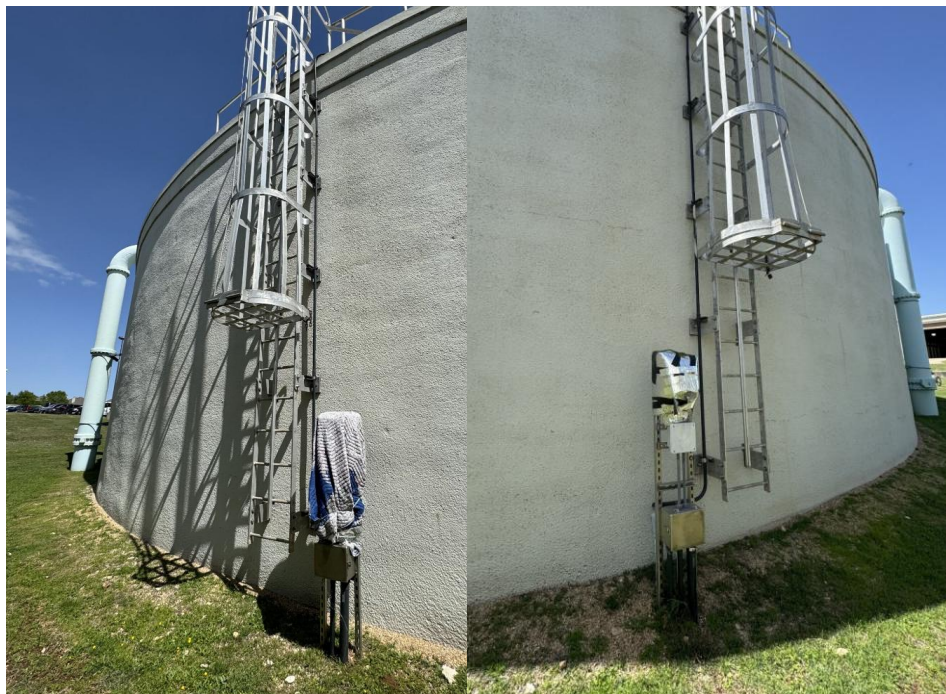
Figure 3-21: Clearwell Meters (Left: Clearwell #1, Right: Clearwell #2)

Garver also recommends installing breathable sun covers over the meters at both clearwells, shown in Figure 3-21, to protect the instrumentation from UV damage and overheating. These recommendations collectively aim to reduce maintenance needs and support long-term operational efficiency.

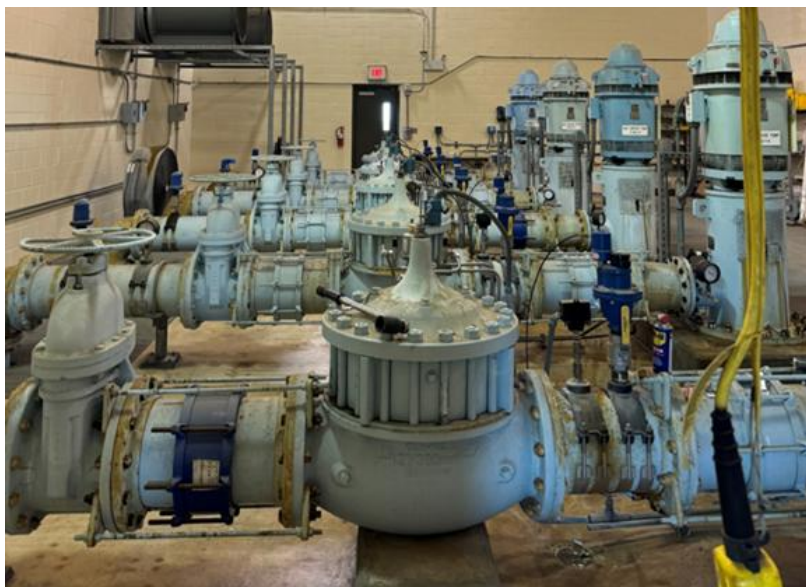
Figure 3-22: High-Service Pump Station

The High Service Pump Station (HSPS), shown in Figure 3-22, is equipped with five Flowserve 15EMM pumps, each rated at 200 horsepower (HP). It is recommended to replace the existing gate valves, ARVs and soft starts at the HSPS due to poor condition, to enhance flow control and reduce maintenance issues.

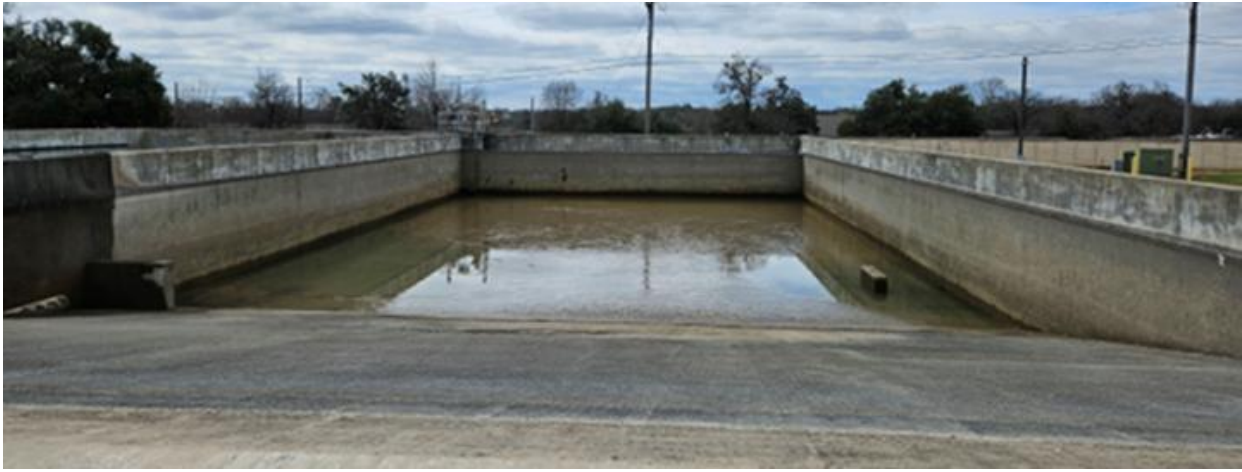
Figure 3-25: Backwash Recovery Basins

Garver and BCMUD operators discussed the drainage issues that operators are having at the backwash recovery basins, shown in Figure 3-25. Currently the waste is settling and not properly draining to the LS, creating extensive manual labor for operators to manage the waste. To improve efficiency and reduce manual labor, Garver recommends installing automated valves and a flow meter to enable gravity drainage of waste to the LS. This setup would automate the discharge process, ensure consistent flow monitoring, and reduce labor demands.

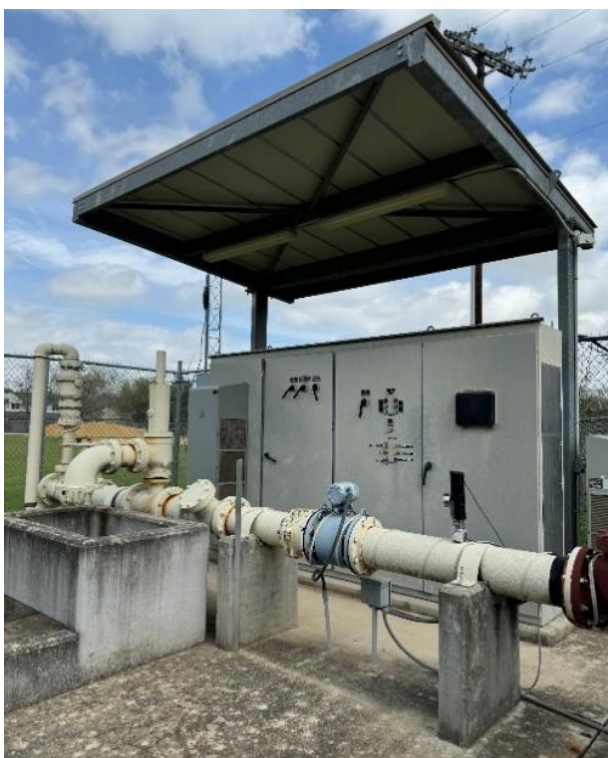
Figure 4-2: Well 3 Panel Enclosure

Additionally, at Well 3, the panel enclosure, shown in Figure 4-2, is recommended to be recoated to preserve its integrity and prevent further weather-related degradation.

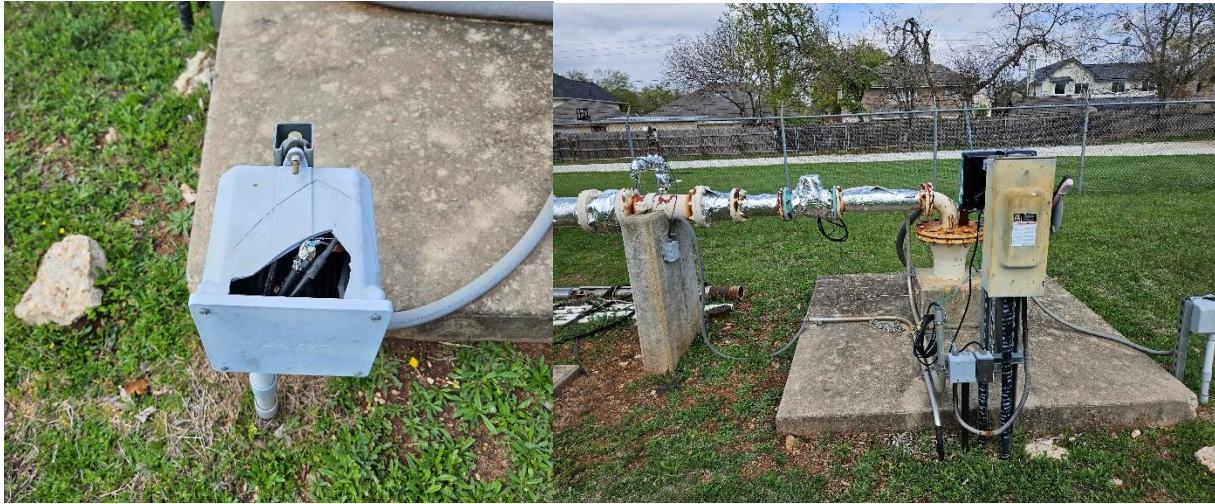
Figure 4-3: Well 5 Electrical Components

At Well 5, two electrical components were flagged for replacement including the local disconnect box and the junction box for the well level reader. Both of these electrical components, shown in Figure 4-3, have since been replaced by BCMUD.

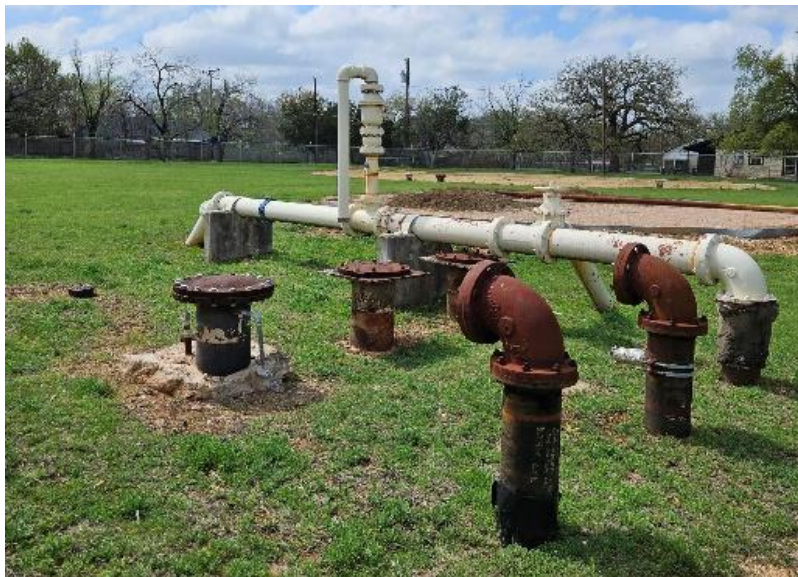
Figure 4-4: Unused Well 5 Piping to be Demolished

Based on BCMUD recommendation, a CIP has been recommended for demolishing unused infrastructure across the wellsite, including the area around Well 5, shown in Figure 4-4, and disconnecting it from the BCMUD system.

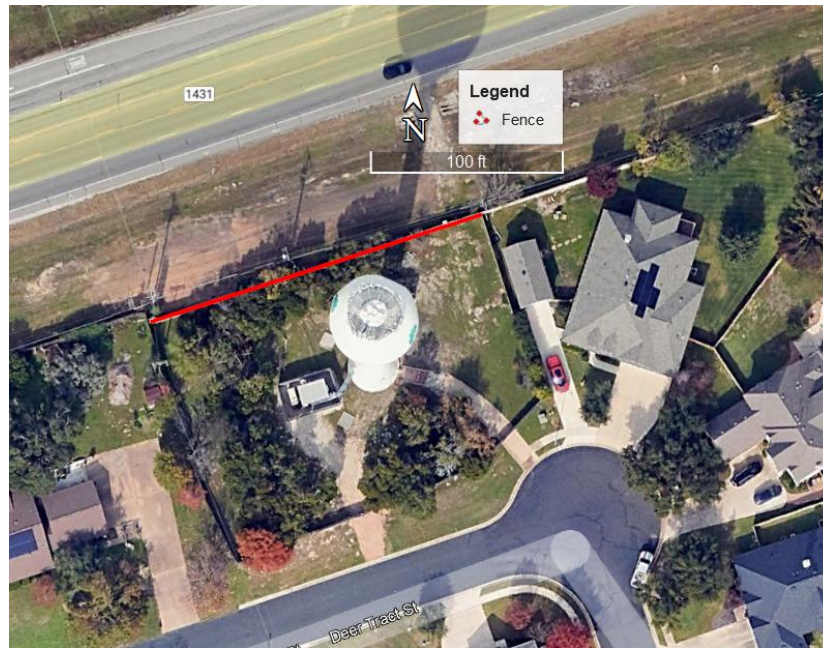
Figure 4-5: North Elevated Storage Tank Fence Replacement

After discussion with BCMUD, it is recommended to replace sections of the EST fencing at both sites to enhance site security and help prevent unauthorized access. These projects are further outlined in Section 9.0, and are scheduled to be implemented within the five-to-ten-year planning horizon. At the North EST, the stone wall that acts as the north section of fencing, highlighted in Figure 4-5, is recommended to be replaced due to condition. Additionally, the utility gate exiting onto RM 1431 as shown in Figure 4-6 is recommended to be replaced as well as per direction from BMCUD staff.

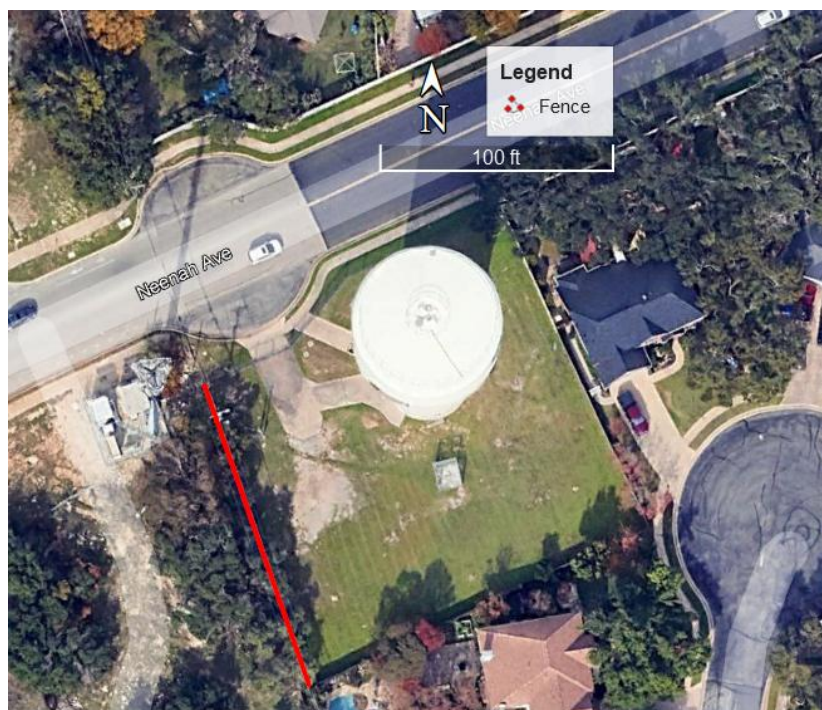
Figure 4-7: Neenah Elevated Storage Tank Fence Replacement

At the Neenah EST, shown in Figure 4-7, the southwest portion of the fence is recommended to be replaced with chain link fence due to poor condition and BCMUD staff direction.

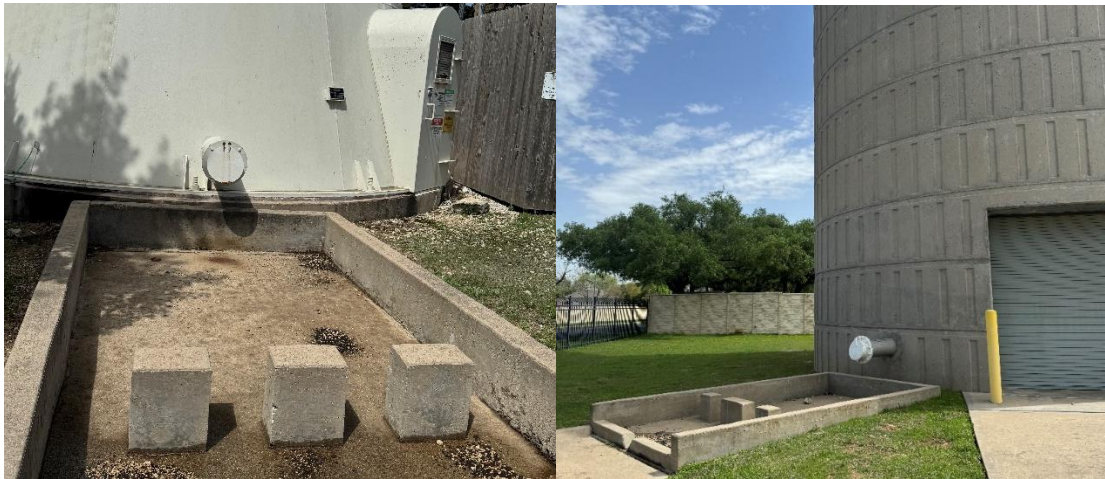
Figure 4-8: Elevated Storage Tank Overflow Systems (Left: North, Right: Neenah)

To extend the operational life of the ESTs, several key improvements were recommended. It is recommended to install an overflow screen, an internal screen that will work in conjunction with the flap seal at the pipe outlet to prevent debris and wildlife from entering the overflow system and protecting water quality and infrastructure. The overflow systems are shown in Figure 4-8.

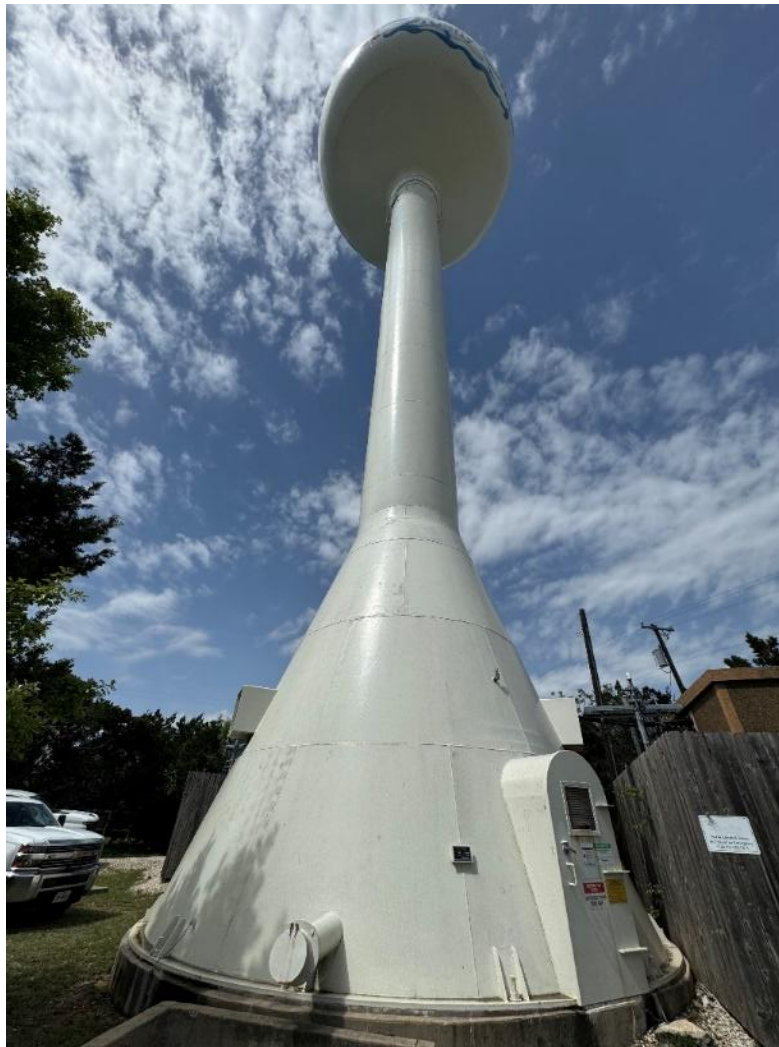
Figure 4-10: North Elevated Storage Tank

Within the five-to-ten-year horizon, a full re-coat of the North EST, shown in Figure 4-10, is recommended to provide long-term protection against weathering and corrosion. It is also recommended to recoat the Neenah EST to maintain the tank's protective barrier and structural integrity. These upgrades collectively aim to preserve the integrity of both towers, ensure regulatory compliance, and support the long-term reliability of the water distribution system.
