Brushy Creek Municipal Utility District

Water & Wastewater Master Plan

Water and Wastewater Master Plan

Garver Project No. 2301754

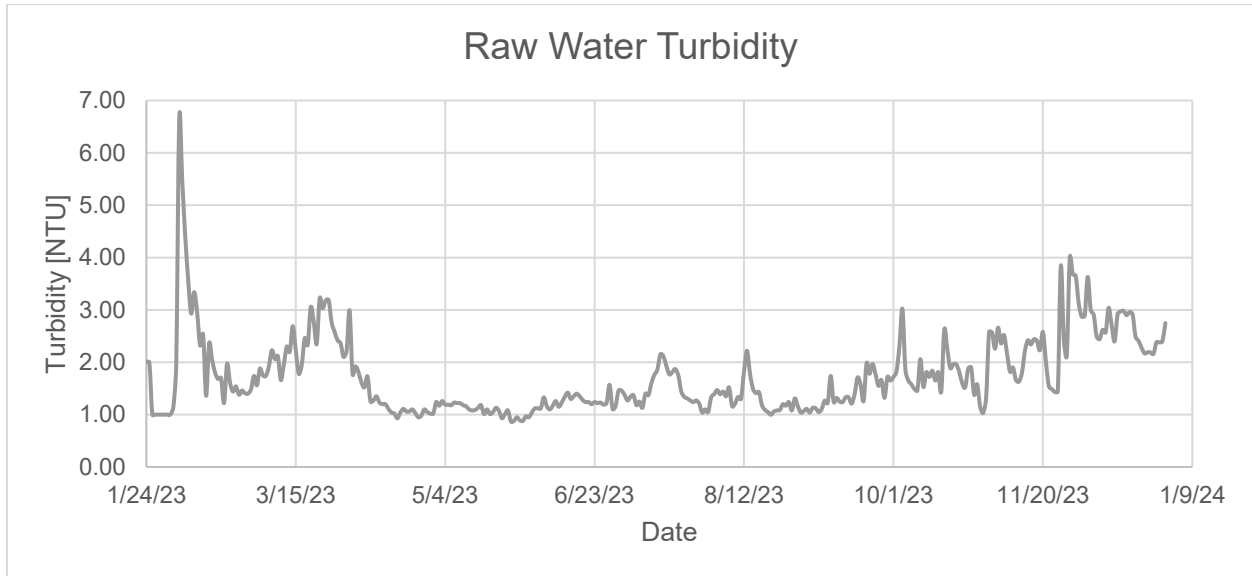
Figure 3-3: Raw Water Turbidity

Figure 3-3 illustrates how turbidity levels in raw water fluctuated between January 24, 2023, to January 9, 2024. Turbidity values ranged from 1.00 to 6.64 NTU, reflecting varying degrees of water clarity. Notable spikes occurred in late January and mid-November, likely due to storm events, and seasonal runoff. Despite these peaks, the baseline turbidity generally remained below 4.00 NTU, with only occasional exceedances. These episodic increases suggest external influences like heavy rainfall or watershed changes. Continuous monitoring is essential to detect such events early and adjust pretreatment and membrane operations accordingly to maintain system performance and water quality.

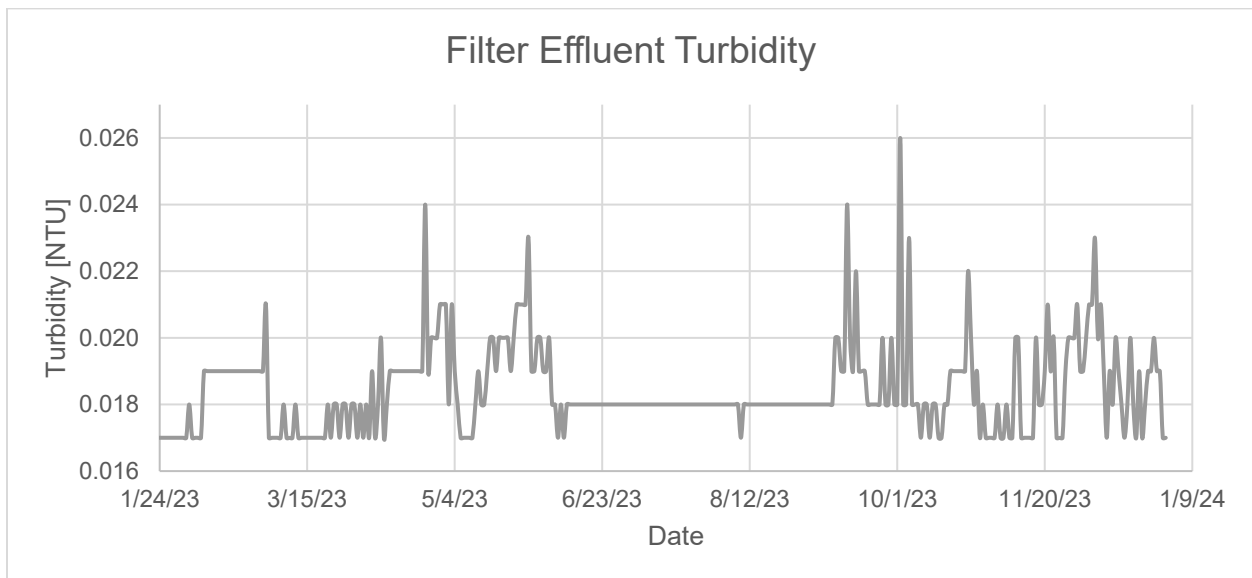
Figure 3-4: Filter Effluent Turbidity

Comparing the influent and effluent turbidity data reveals that the treatment process is performing effectively. While the raw water turbidity (influent) fluctuates significantly, ranging from 1.00 to 6.64 NTU with notable peaks, the filter effluent turbidity, shown in Figure 3-4, remains consistently low, between 0.02 and 0.03 NTU. This indicates that the membrane filtration is successfully removing the majority of suspended solids and particulates, even during periods of high turbidity in the raw water. The effluent turbidity values are well below typical regulatory limits of 0.3 NTU, demonstrating excellent process control and filtration performance.

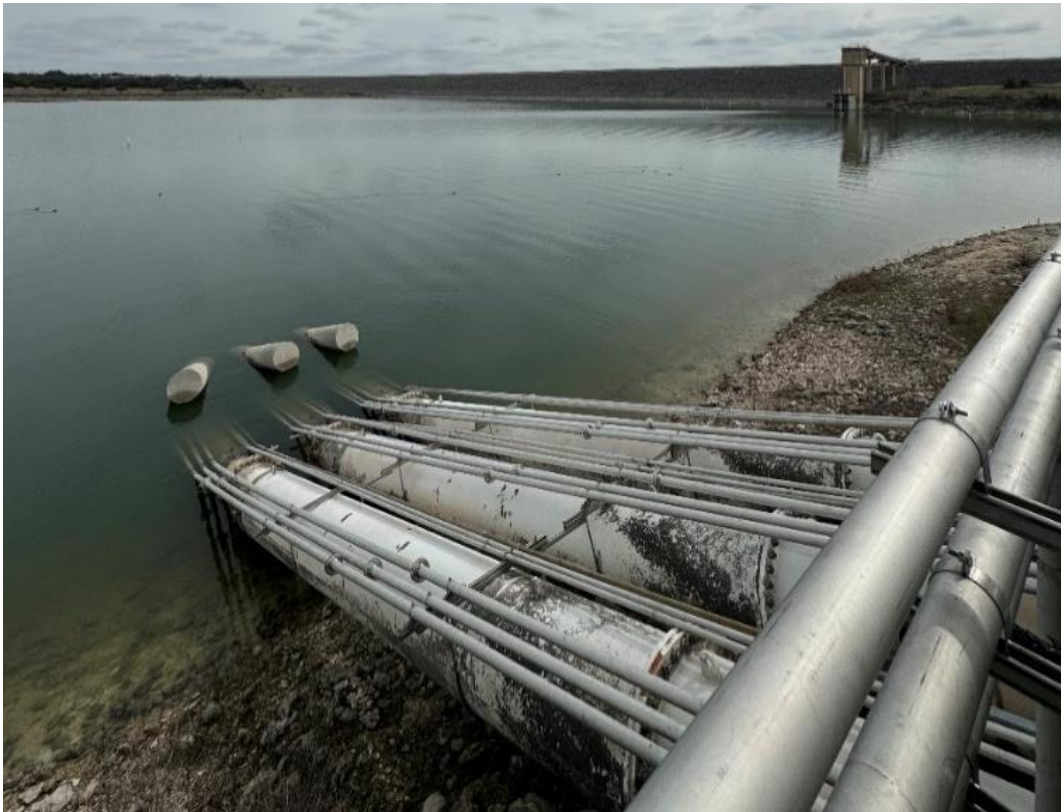
Figure 3-5: Raw Water Intake at Lake Georgetown

The raw water intake at Lake Georgetown, shown in Figure 3-5, is located at 3504 FM 261 CIR, Georgetown, Texas. The raw water intake supplies most of the raw water for BCMUD, with a firm capacity of 5.9 MGD. The raw water intake is currently under construction of a winterization and electrical improvements project, which includes the installation of a generator and upgrades to the Motor Control Center room; construction on the project is estimated to be complete by September 2026. Within the zero-to-ten-year planning horizon, the singer control valves, ARVs, and the 24-inch raw water meter need to be replaced, as well as full rehabilitation of the surge tank per direction from BCMUD.

Additionally, based on direction from BCMUD, Garver has recommended a CIP to recoat the piping inside and outside the vault, implementing badge access security improvements for all buildings, and replace pump #1 with an upsized pump at the raw water intake facility. These recommendations are included as a CIP in Section 9.0, and are scheduled to be implemented within the five-to-ten-year planning horizon.

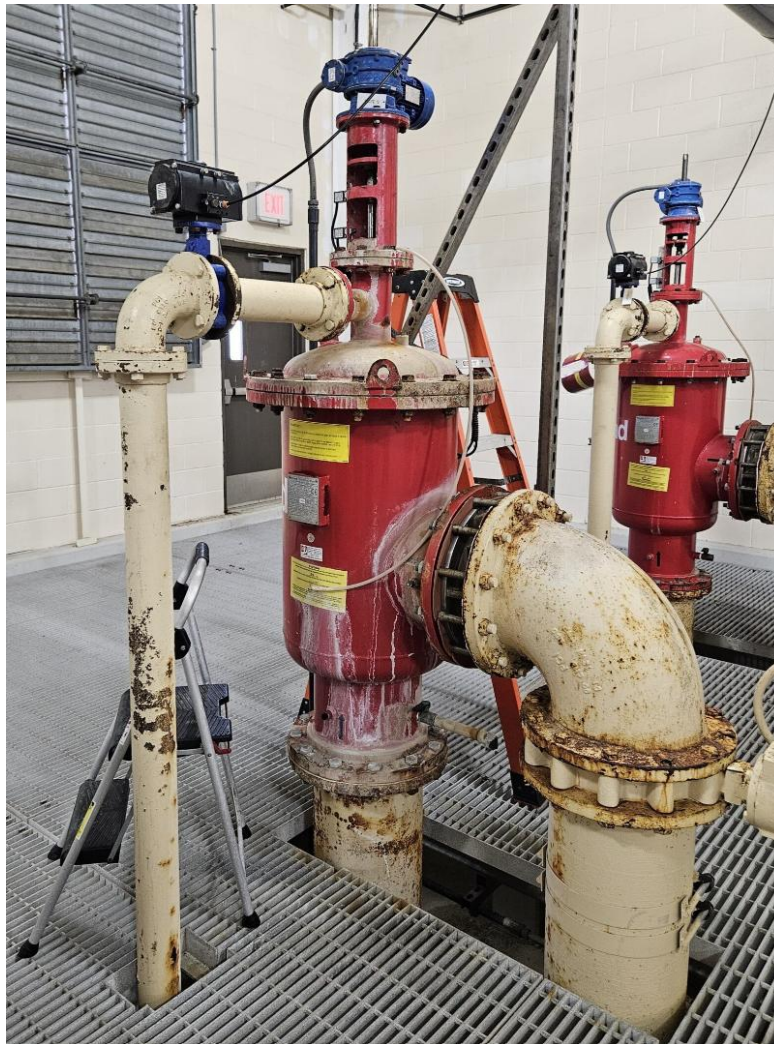
Figure 3-10: Amiad Strainers

Garver analyzed the Amiad strainers, shown in Figure 3-10, during the site visit. Since then, a full evaluation has been conducted by the manufacturer. The results of the evaluation were that two needed to be rebuilt and the third did not need repairs. The strainers are being recoated as part of a project that will start construction in September 2025. No other recommendations are noted at this time.

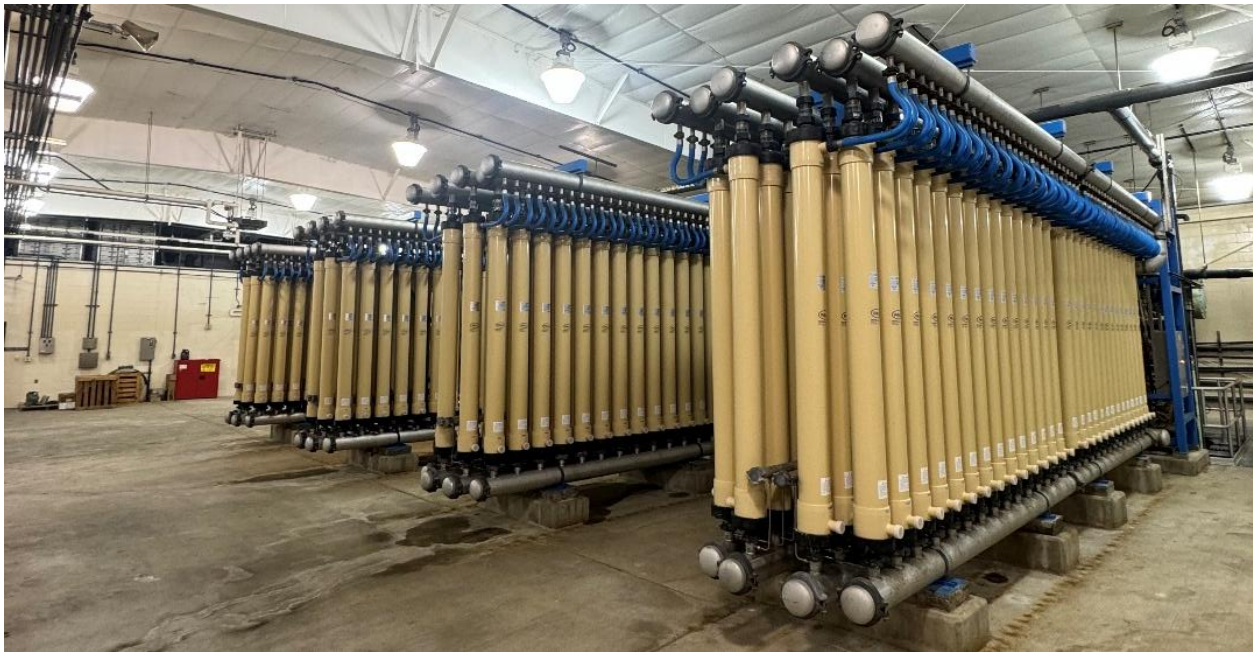
Figure 3-11: Pall Membrane Racks

A comprehensive review of the Pall Membranes revealed no operational issues or parameters hindering production. The integrity test results were thoroughly evaluated and found to be satisfactory, indicating that the membranes are functioning as intended. From a process standpoint, there are no concerns regarding the current operation of the membrane units; supporting components such as coagulant dosing, and total dissolved solids levels were all reviewed and deemed appropriate. Historical data shows no recurring patterns of concern, and the overall process remains stable and predictable.

The membrane replacement schedule was reviewed and found to be appropriate, with no changes recommended at this time. BCMUD should continue monitoring performance data and the existing membrane replacement schedule. Adding an additional membrane filter rack is recommended as a means of reducing membrane-related maintenance. The additional unit will reduce operating flux and TMPs across all units. Since backwashing is throughput (volume based), the additional rack will also extend the time between backwash cycles. Although the extension will not result in a net improvement to water recovery, the time extension will reduce the number of backwashes performed on a daily basis, which will also reduce cyclic fatigue and open/close related loss of life for cyclic pressurized equipment. This reduction in number of cycles per day and required operation pressure is expected to have a direct impact on operation life for the membrane feed pumps (which should operate at lower speeds), membrane unit valves and membrane filter elements. Additionally, during summer peak demands, taking one membrane rack offline presents operational challenges, as the remaining three racks are insufficient to meet production demands over multiple days. The addition of a fifth membrane unit will provide the necessary flexibility, allowing one rack to undergo maintenance while the other four continue to operate within capacity. The recommendations and CIPs are outlined in Section 9.0. When the WTF was built in 2012, there was a designated space left for BCMUD to add two additional membrane racks as shown visually in Figure 3-15 and in the plans in Figure 3-16.

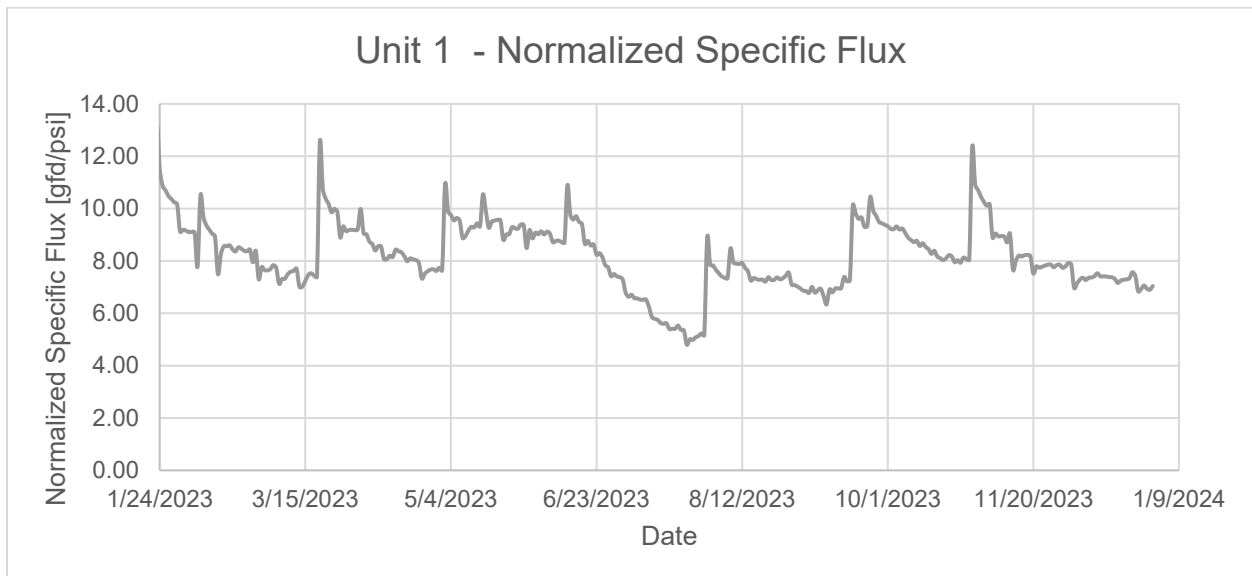
Figure 3-13: Unit 1 - Normalized Specific Flux

The four units have similar performance metrics, Unit 1 is elaborated on below, all other unit data is provided in **Appendix D**. The normalized specific flux data for Unit 1, shown in Figure 3-13, shows stable membrane performance over the course of 2023. There are periodic fluctuations, but no long-term decline, indicating effective cleaning and operational practices. Peaks in the data likely correspond to post-cleaning recovery, and increased filtrate flow to accommodate heavier loading in the summer months, while troughs appear to be temporary and recoverable. The absence of a downward trend suggests that the membrane is not experiencing significant fouling or degradation. Overall, the system is operating predictably and within expected performance parameters.

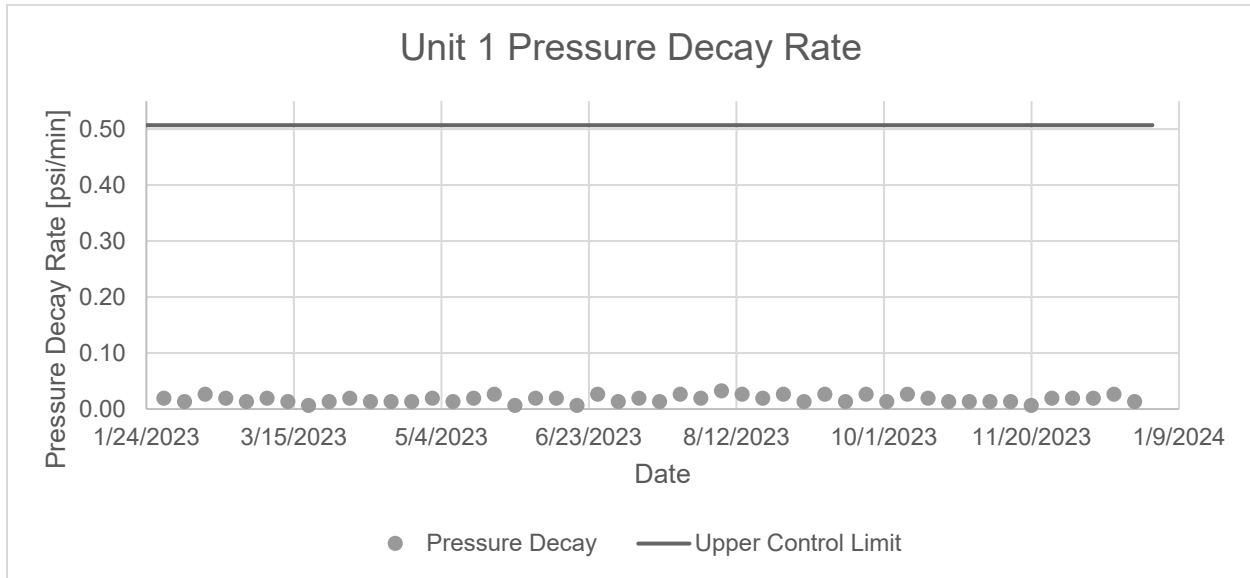
Figure 3-14: Unit 1 - Pressure Decay Rate

The pressure decay rate data for Unit 1, shown in Figure 3-14, indicates stable membrane integrity over the monitoring period. All recorded values remain consistently below the established upper control limit of 0.507 pounds per square inch (psi)/min, suggesting no breaches or abnormal pressure loss. The data points show minor fluctuations which are expected in normal operations but do not approach concerning levels. This consistency supports the conclusion that the membrane system is maintaining its structural integrity. Overall, the pressure decay performance confirms reliable and predictable operation of Unit 1.

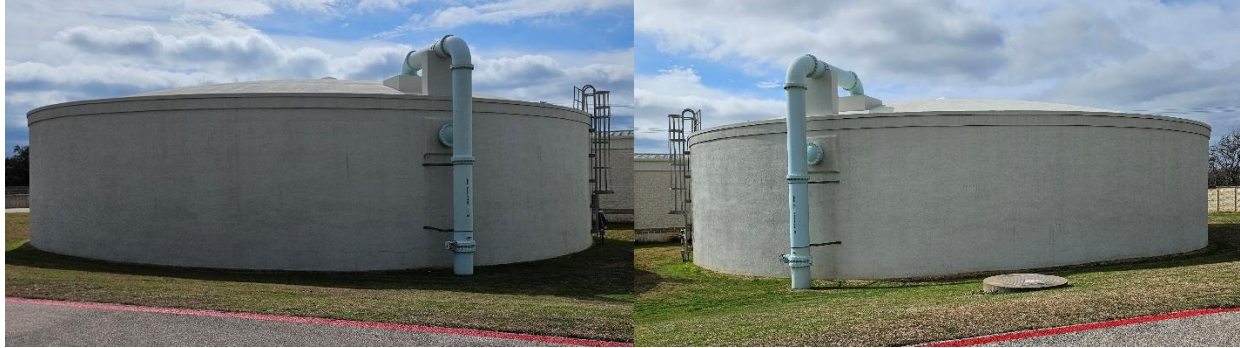
Figure 3-19: Clearwells #1 & #2 (Left: Clearwell #1, Right: Clearwell #2)

On June 6, 2024, Garver conducted a site visit to evaluate the condition of BCMUD's 2.0 MG clearwells, that are located at the WTF, shown in Figure 3-19. Several improvements are recommended after conducting the analysis to increase their functionality and longevity.

For Clearwell #1, it is recommended to add a continual gravel overflow to help manage overflow water effectively and direct the flow properly to the pavement. It is also recommended to install a drain for the clearwell to be emptied, as well as a tank mixer as specifically requested by BCMUD staff. For Clearwell #2, similar upgrades are proposed, including the addition of an overflow splash pad similar to the existing infrastructure at Clearwell #1, and to install a dedicated drainage system for the overflow to manage and mitigate the water and reroute it away from the recommended location of the emergency interconnect vaults. The existing drainage infrastructure is shown in Figure 3-20. Refurbishing the wire mesh at the overflow of both clearwells will restore effectiveness in screening debris and maintaining water quality.

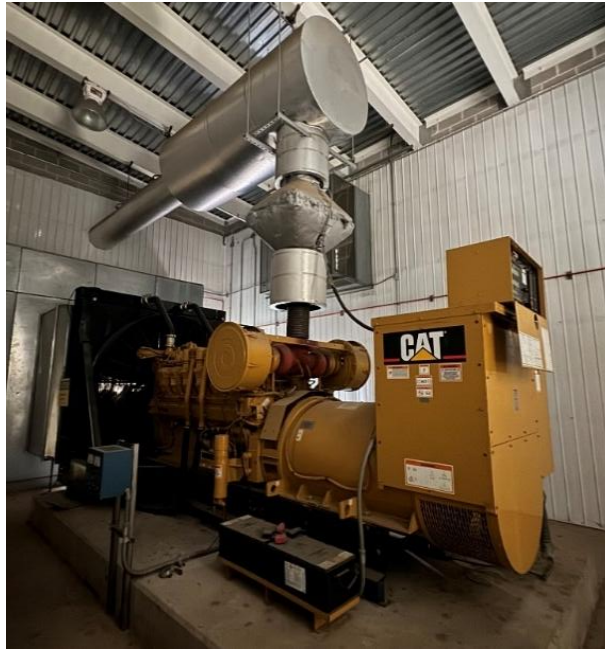
Figure 3-23: WTF Generator

Garver and BCMUD operators discussed the challenge of ventilation in the generator room due to the louvers not opening properly when the generator, shown in Figure 3-23, is running.

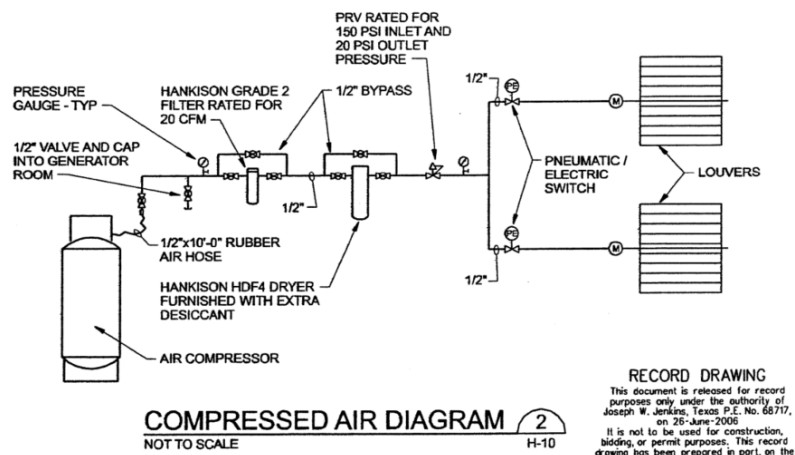
Figure 3-24: Generator Room Compressed Air Diagram

The louvers were actuated by a compressed air system, shown in Figure 3-24, but are currently being converted to electrical actuators powered by the uninterruptible power supply (UPS) as a part of ongoing HVAC and mechanical work at the WTF. To ensure airflow in the event of failure, the louvers are going to be mechanically left open to prevent unintentional issues and damage. There are no additional recommendations for the generator room at this time.

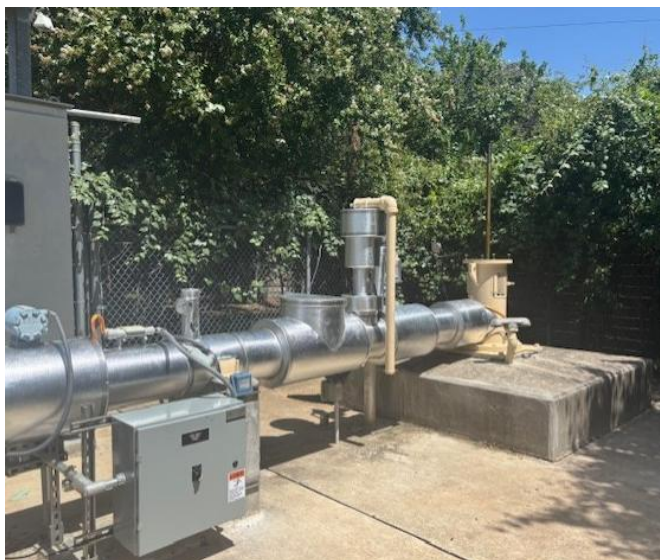
Figure 4-1: Well 3 Piping

The Well 3 pump, shown in Figure 4-1, was installed in 2011 and is performing as designed. The Well 3 motor is currently being rewound. No additional reports or issues were noted and therefore, no recommendations for replacement or repair are suggested at this time. BCMUD should continue to monitor the condition of the pumps and upgrade when pump performance issues start to arise as the pump reaches the end of its service life.

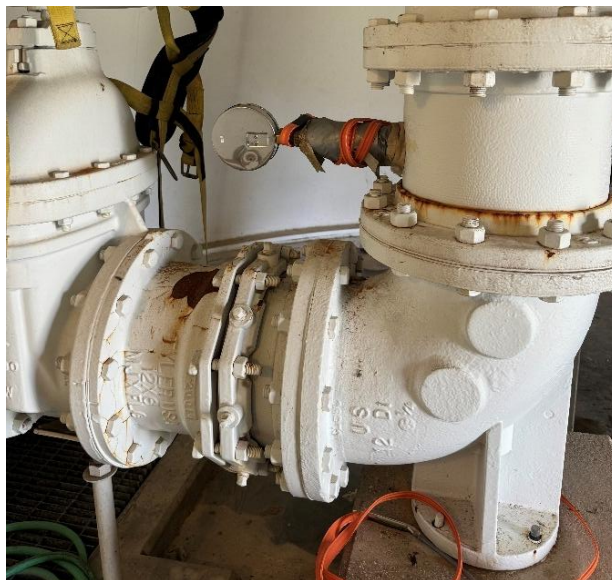
Figure 4-9: North Elevated Storage Tank Pipe Corrosion

At the North EST, there was evident degradation of the ground level pipework, shown in Figure 4-9. It is recommended to re-coat the ground-level pipework to address corrosion and condition issues. Additionally, a mildew power wash is recommended for the exterior surface for not only improving aesthetics but also preventing biological growth.

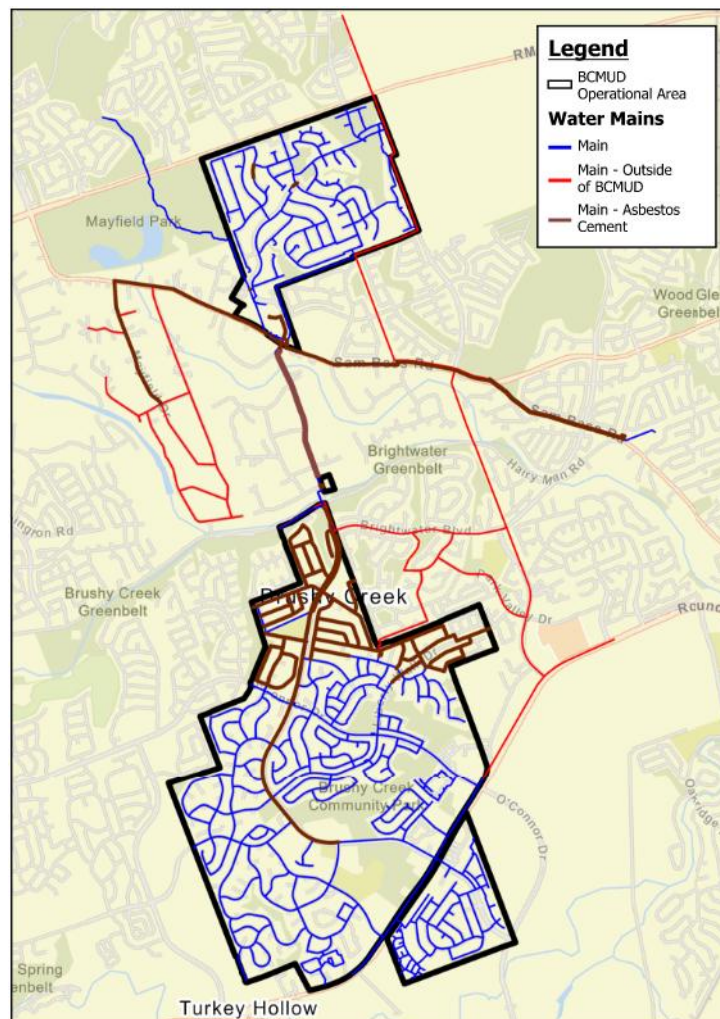
Figure 4-11: Map of Asbestos Cement Pipe Locations

Pipe asset information was reviewed to develop recommendations for repair or replacement. Garver reviewed historical leak data, previous waterline studies, and the previous asset management plan to identify any proposed improvement projects needed. BCMUD has 64 asbestos cement (AC) pipe locations within its water system as shown in Figure 4-11. The estimated service life of AC pipe fluctuates based on the water characteristics but estimates are about 30-50 years. AC pipes pose serious health risks because they contain microscopic fibers that can cause lung diseases like mesothelioma and asbestosis when inhaled. However, these risks are minimal when the pipes remain undisturbed underground, as the asbestos is non-friable and unlikely to release fibers. Removing the pipes can be more dangerous than leaving them in place, since cutting or breaking them during excavation can release hazardous airborne fibers. Garver conducted an initial assessment on the condition of the AC pipelines to determine if replacement is recommended.

Should the asbestos fibers increase in the sampling, then BCMUD should consider removing AC pipe from the distribution system. An alternative to full replacement of these AC pipe locations would be cured-in-place pipe (CIPP) which is a trenchless rehabilitation method that can be pursued.

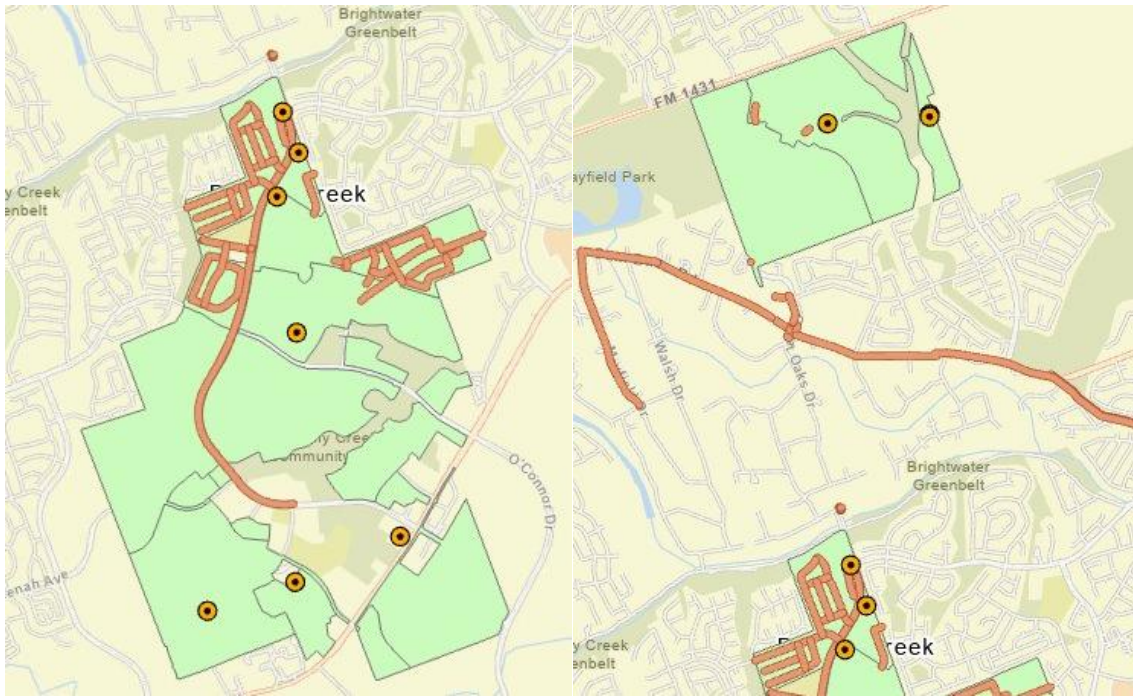
Figure 4-13: Water Main Leak Data

Garver then filtered the data with assistance from BCMUD to isolate the water main, and public side service line leak data starting in 2013, to find a correlation between leak data and AC pipe water mains. Unfortunately, this exercise was unsuccessful. As shown in Figure 4-13 the leak data was scattered and inconclusive.

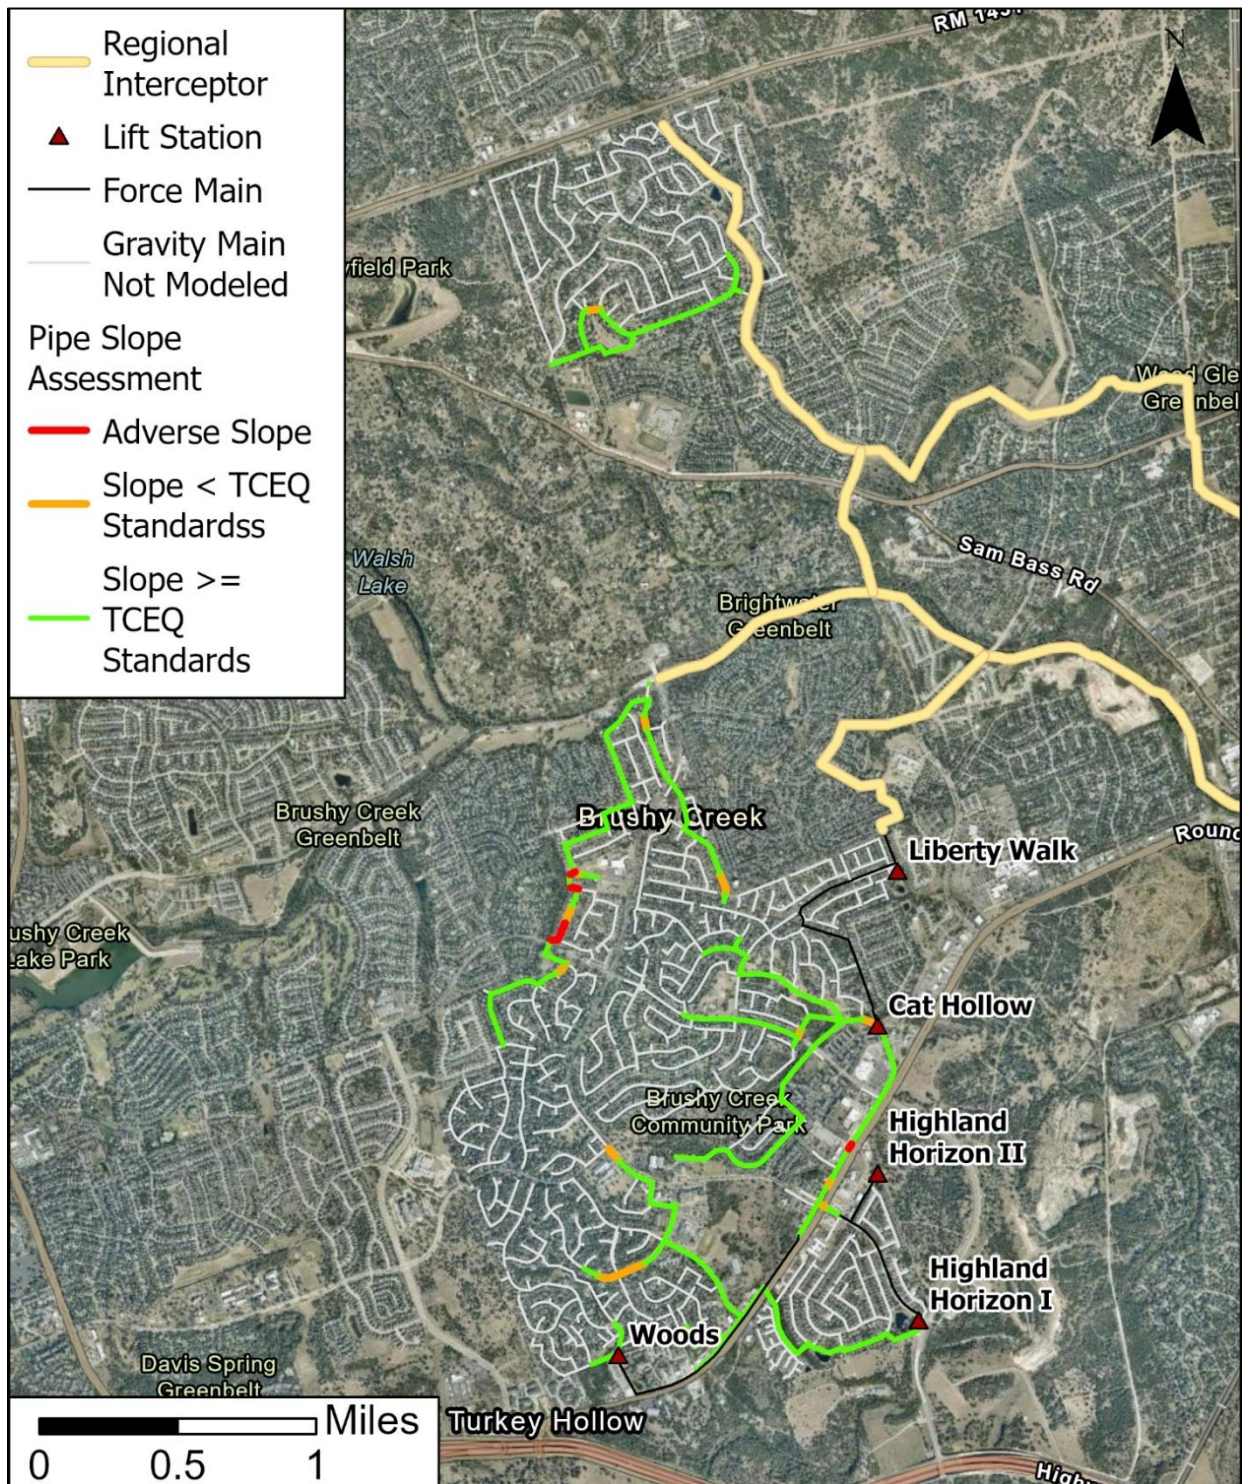
Figure 7-5: Pipe Slope Assessment

Figure 7-5 shows the results of the pipe slope assessment per TCEQ minimum slope criteria, which this study considers to be a Tier 2 evaluation criterion. The figure highlights pipes that are flatter than the TCEQ criteria, which requires pipe slopes to achieve a minimum velocity of 2 fps when flowing full, as calculated by Manning's equation. As shown in the map, there are several gravity main segments that have slopes flatter than TCEQ criteria. Additionally, there are a few gravity main segments that have adverse slopes. Pipe elevations are taken from the GIS database and from manhole invert measure-downs subtracted from LIDAR ground elevations. While BCMUD staff did collect measure-downs for many of the adverse-slope pipe segments, there is still some uncertainty in actual pipe invert elevations, as precise manhole rim elevations are unknown. Manhole rim elevations were interpolated from LIDAR data. It is therefore recommended that adverse slope and flat slope pipe segments be verified by survey.

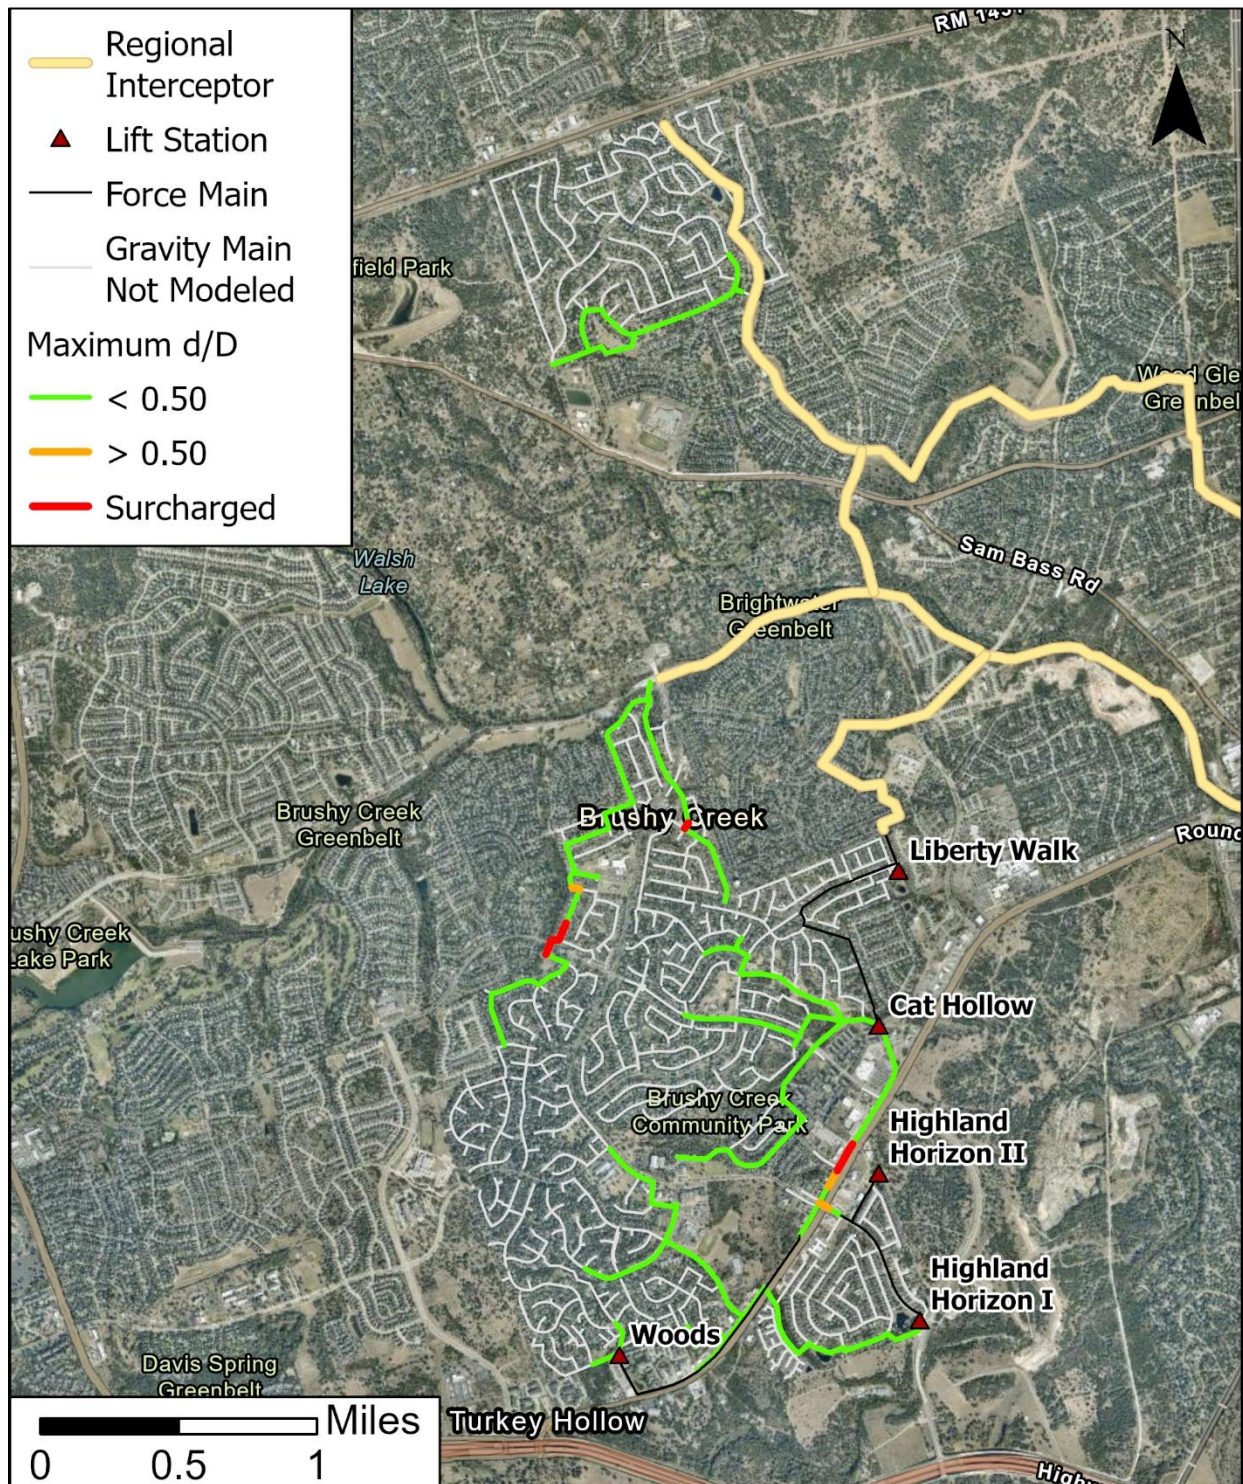
Figure 7-6: Dry Weather Capacity Assessment Results

Figure 7-6 shows the dry weather capacity assessment results. This map displays maximum d/D values for average day flows. The Tier 2 capacity criteria for this flow scenario states that maximum d/D should not be greater than 0.50. The map highlights several gravity main segments that have d/D values greater than 0.50, or that are surcharged. All pipes in violation of the dry weather criteria are caused by pipes that have adverse slopes or have slopes flatter than TCEQ criteria.

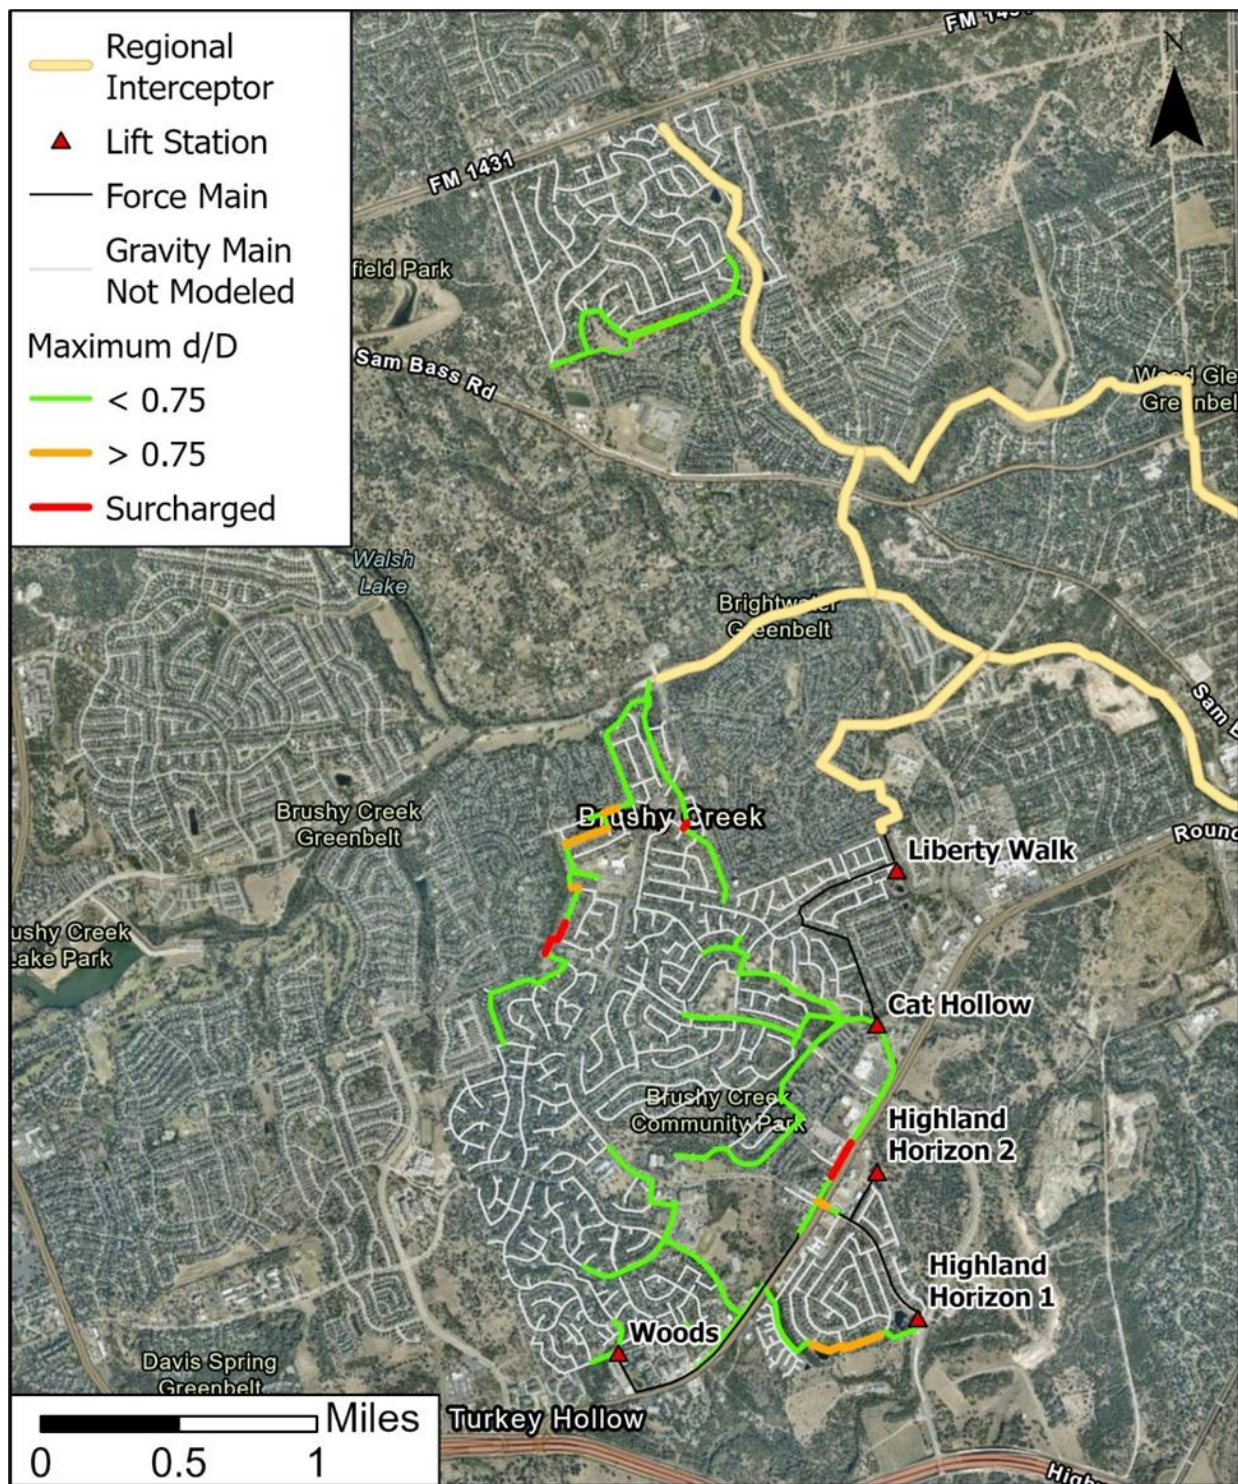
Figure 7-7: Wet Weather Capacity Assessment Results

Figure 7-7 shows the wet weather capacity assessment results. This map displays maximum d/D values for wet weather flows. The Tier 2 capacity criteria for this flow scenario states that maximum d/D should not be greater than 0.75, and the Tier 1 capacity criteria states that no gravity mains should be surcharged. As shown on the map, there are several segments of gravity main that are surcharged. The surcharged gravity mains correspond to the locations that have adverse slopes. There are also several gravity main segments that are not surcharged and have maximum d/D values greater than 0.75. Most of these segments correspond to areas with flat or adverse slopes, except for the gravity main segment upstream of Highland Horizon I LS and in the gravity main segment in northern gravity main basin (north of Sam Bass Road).

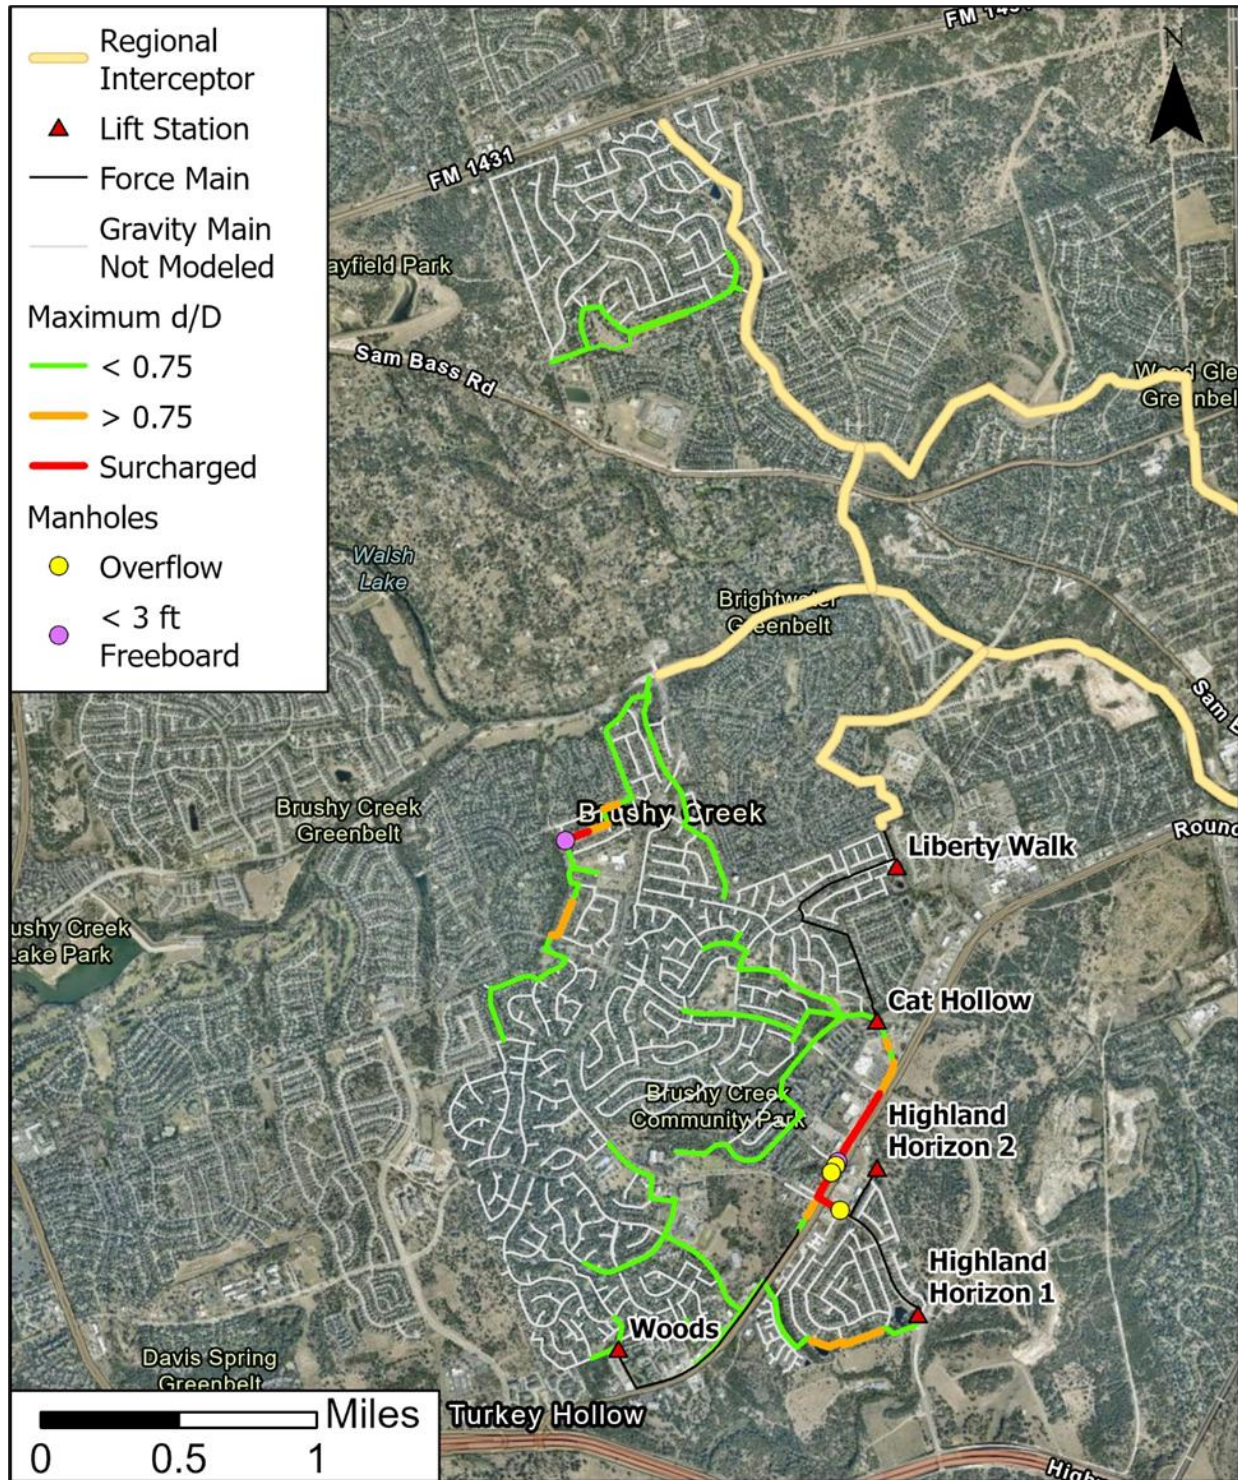
Figure 7-8: Increased Wet Weather Peaking Factor Risk Analysis Scenario

Figure 7-8 shows the results of the increased wet weather peaking factor risk analysis scenario. As shown in the figure, there are several segments of gravity main that are surcharged, and several manholes that experience low freeboard conditions or overflows. Flows to these areas should be prioritized for monitoring if a temporary flow monitoring program is deployed.

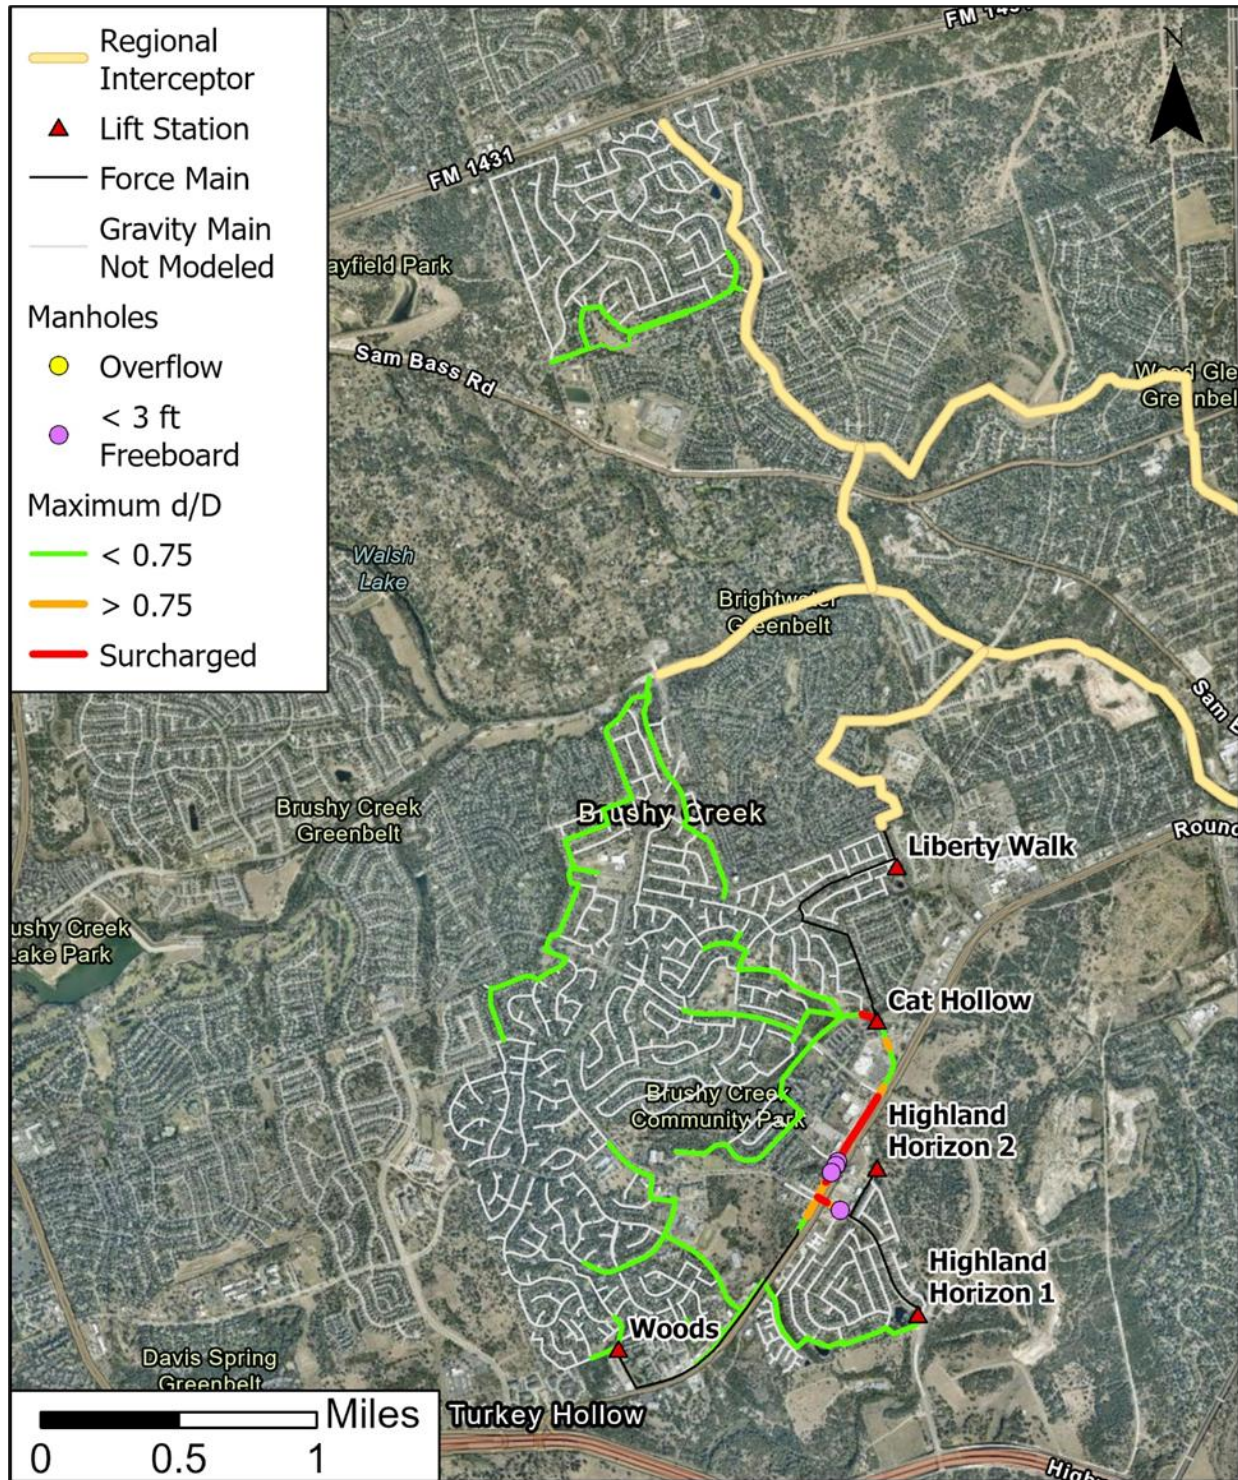
Figure 7-9: All LSs Operating at Firm Capacity Risk Analysis Scenario

Figure 7-9 shows the results of the risk scenario for all pumps operating at firm capacity. As shown in the figure, there are several segments of gravity main that are surcharged and several manholes that experience low freeboard conditions or overflows downstream of the lift stations. Pumped flows from the lift stations should be monitored, and downstream capacity upgrades should be considered if it is found that the LSs are often operating at firm capacity during wet weather events.

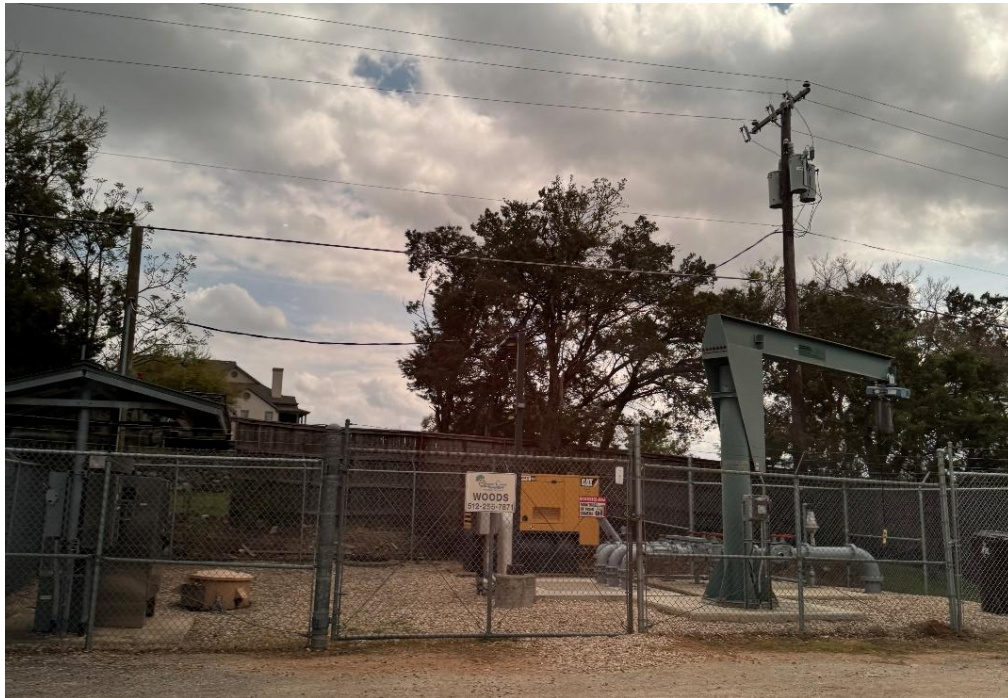
Figure 8-1: Woods Lift Station

The Woods LS, shown in Figure 8-1, was evaluated during the site visit and was found to be in good operational condition. BCMUD staff has identified CIPs for this LS including demolishing and filling the dry pit for safety, updating SCADA to allow remote operations, and installation of a grinder pump to address ragging issues. These recommendations have been outlined in Section 9.0, and are scheduled to be implemented in the zero-to-five-year planning horizon.
