Brushy Creek Municipal Utility District

Water & Wastewater Master Plan

Water and Wastewater Master Plan

Garver Project No. 2301754

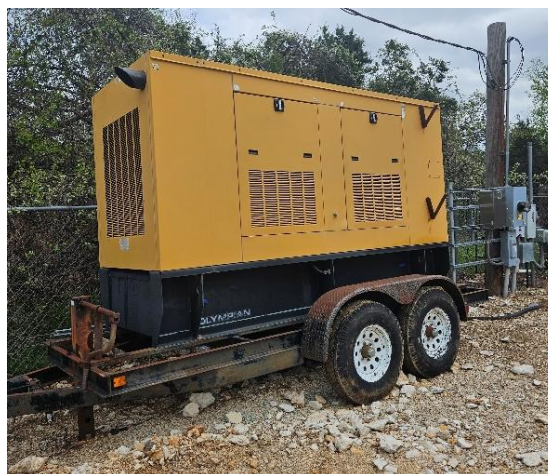
Figure 8-4: Liberty Walk Mobile Generator

A new permanent generator mounted on a concrete pad with an automatic transfer switch is recommended to ensure continuous power during outages. This project was recommended by BCMUD staff because the current mobile generator onsite, shown in Figure 8-4, is oversized, nearing the end of its life, and loud for nearby residents when in use. This recommendation supports Texas Senate Bill 3 and Texas Water Code §13.1394, which outlines that utilities are required to ensure continuity of service during extended power outages.

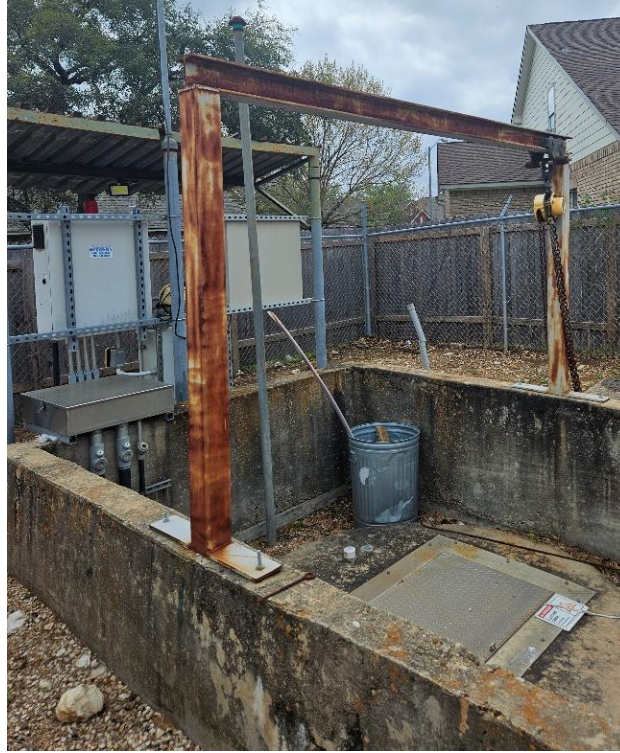
Figure 8-5: Liberty Walk Lift Station Jib Crane

The existing jib crane, shown in Figure 8-5, should be replaced or rehabilitated to improve maintenance efficiency and worker safety due to its poor condition.

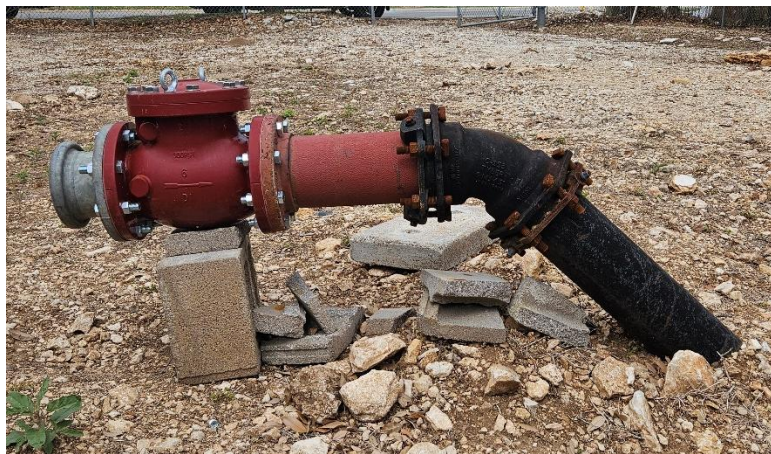
Figure 8-6: Liberty Walk LS Pipe Stanchion

It is recommended to install a pipe stanchion to support the bypass pump line and prevent mechanical stress to replace the existing stone stack shown in Figure 8-6.

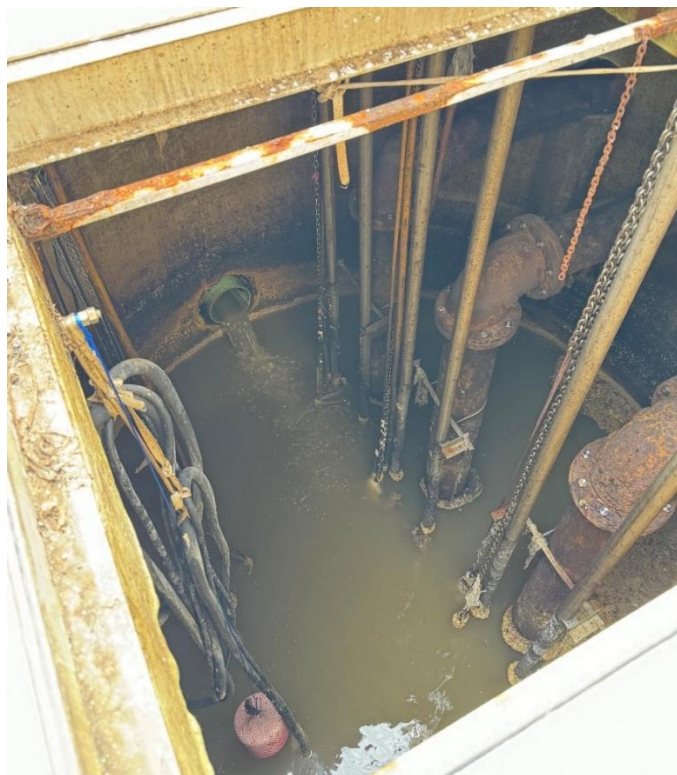
Figure 8-7: Highland Horizon I Lift Station Wet Well

The Highland Horizon I LS CIP targets improvements to enhance safety and operational efficiency. To improve worker safety, fall protection systems should be installed at the wet well access hatches since there is no fall system currently in place, shown in Figure 8-7. To improve operational efficiency, a grinder pump is recommended to be installed to prevent ragging issues in the wet well.

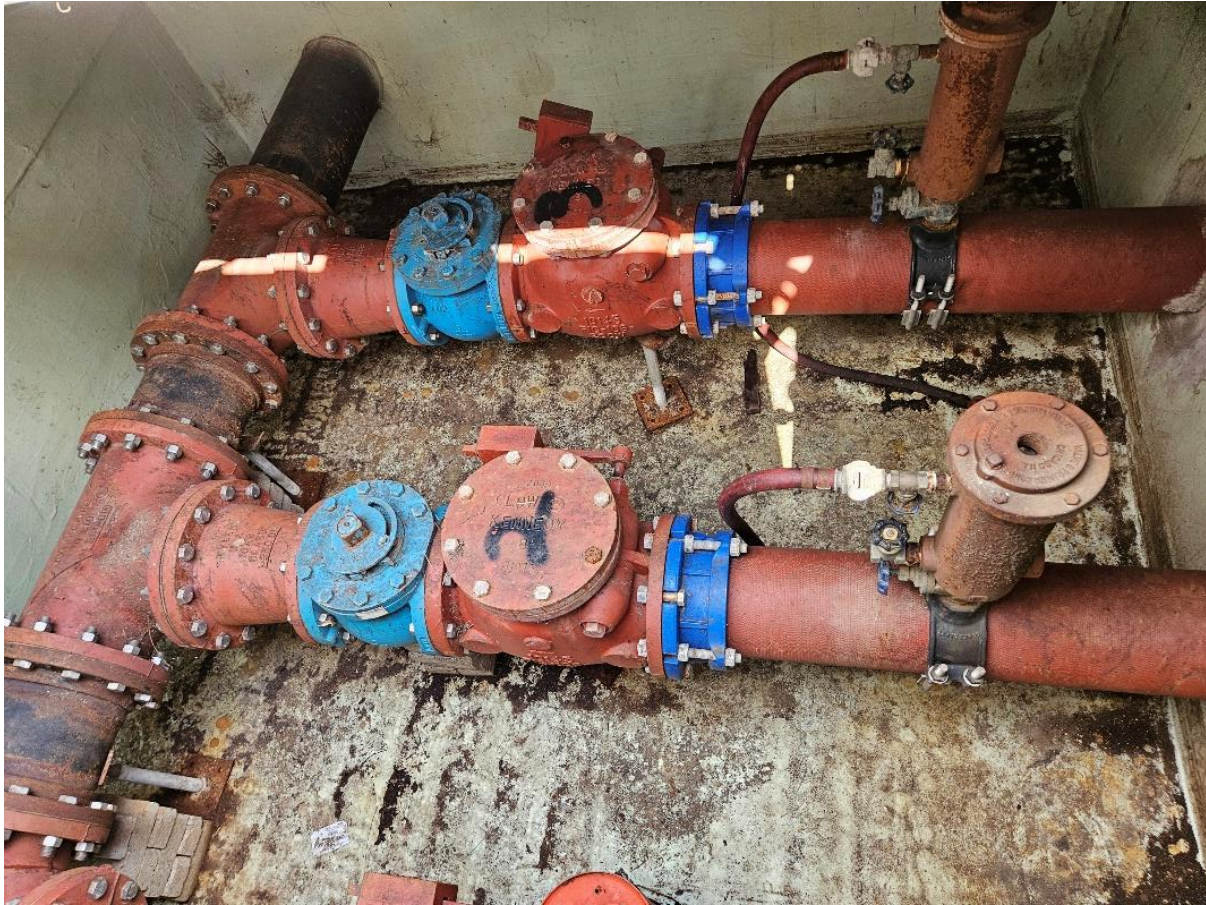
Figure 8-8: Highland Horizon I LS Pipe Stanchions

The existing pipe stanchions in the vault should be replaced to ensure proper support and alignment of piping systems. This will reduce the risk of mechanical failure that is possible with the current pipe stanchions due to their critical condition, shown in Figure 8-8.

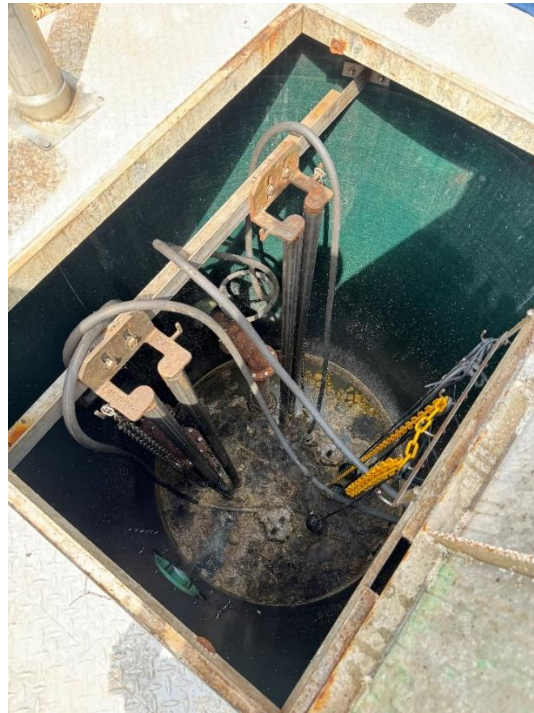
Figure 8-9: Highland Horizon II Wet Well

The Highland Horizon II LS CIP targets improvements to enhance safety and operational efficiency. To improve worker safety, fall protection systems should be installed at the wet well access hatches since there is no fall system currently in place, shown in Figure 8-9.

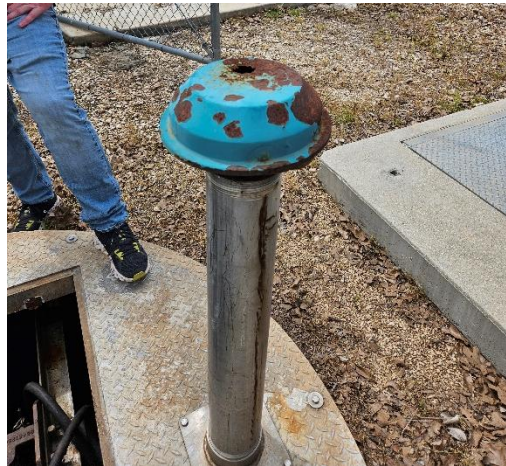
Figure 8-10: Highland Horizon II Corroded Vent

The vent at Highland Horizon II LS is corroded, shown in Figure 8-10, and is recommended to be replaced.

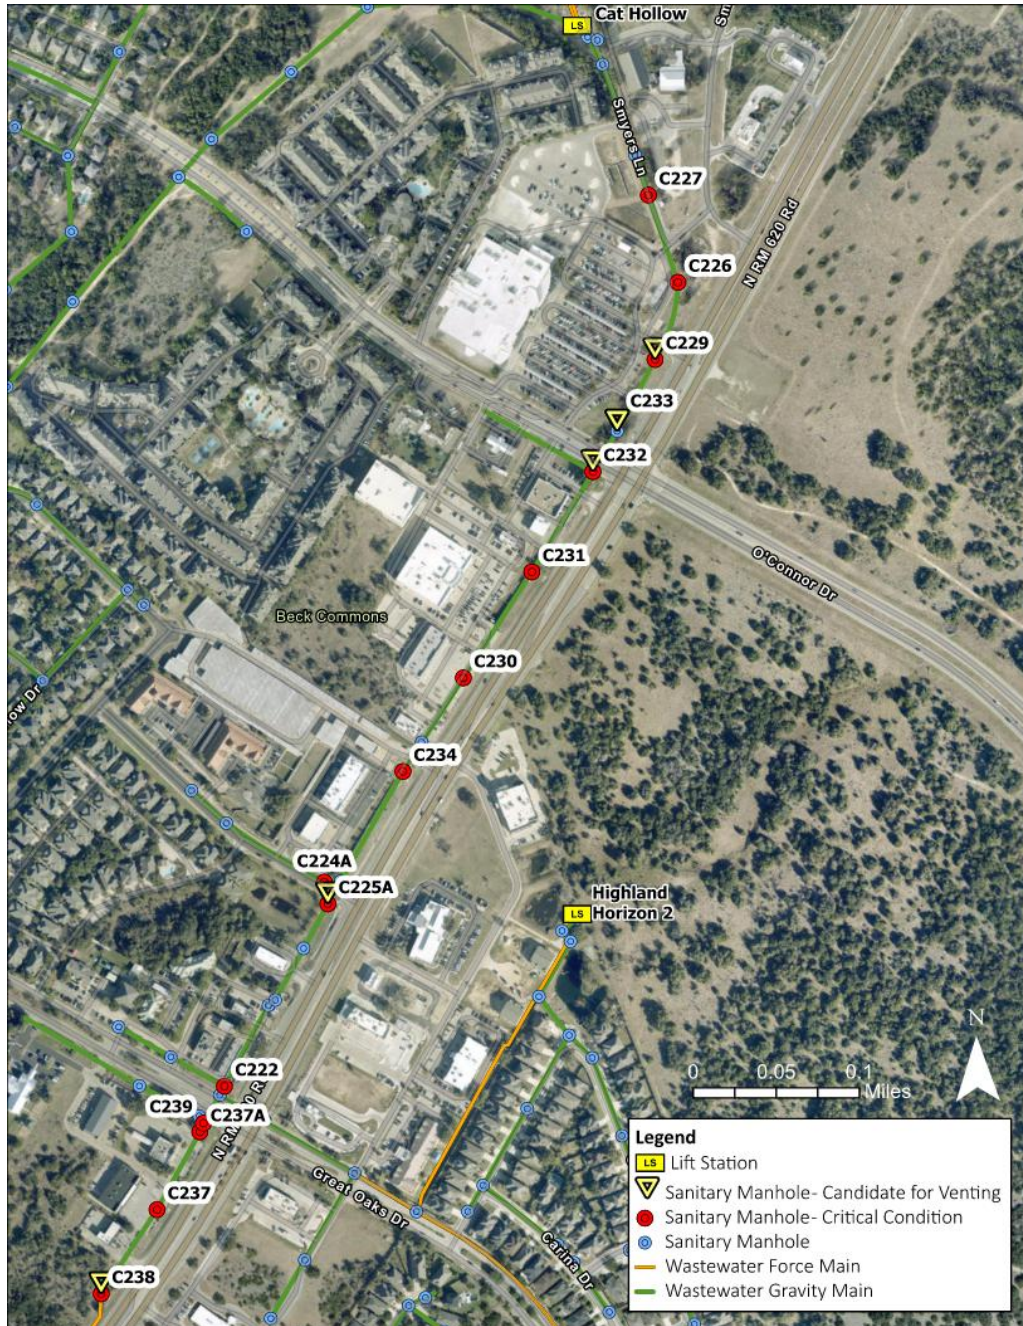
Figure 8-11: Manhole Locations for Rehab and Venting

Garver conducted a site visit to evaluate the condition of selected BCMUD's manholes. The critical manhole locations that were evaluated were located along N 620 Road as shown in Figure 8-11.

The critical manholes identified for rehabilitation are listed in Table 8-1. BCMUD has elected to rehabilitate by coating instead of conducting a full manhole replacement. During the recoating process, the WW main will be temporarily plugged and bypassed to continue WW service operations to the CORR Wastewater Treatment Facility. To preserve the rehabilitation and extend the service life of the coating, Garver recommends installing vents at certain manholes to release the sewer gases from the manhole. These vented manhole locations as shown in Figure 8-11, are strategically placed to prioritize areas that are will not cause odor concerns for the public.

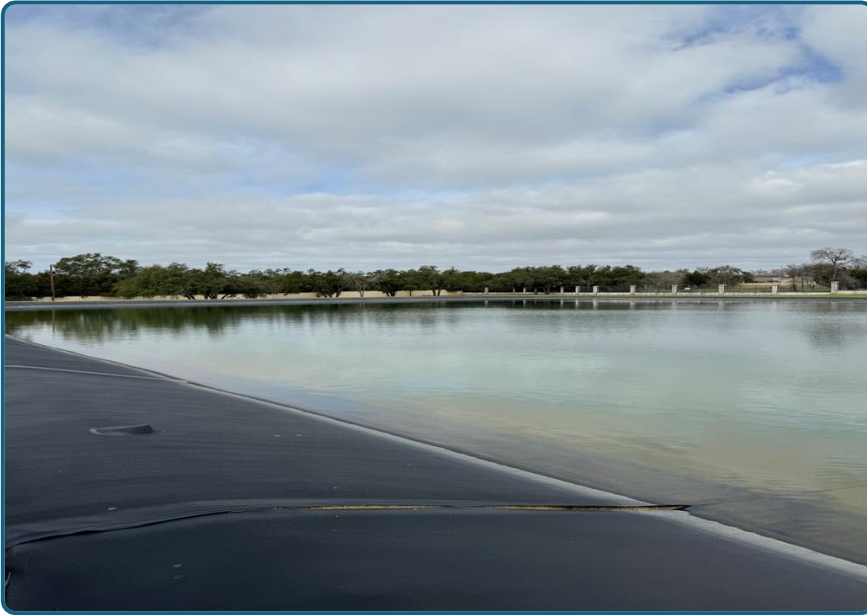
CIP 2: Raw Water Reservoir Geomembrane Replacement

1. Replace the entire raw water reservoir geomembrane to prevent water loss from the existing cracks in the geomembrane. Titan Environmental USA recommends to replace the geomembrane based on results from the integrity, break elongation and stress crack resistance test.

Repair broken sections of the liner in patches.
